# UNITED STATES CONSULATE GENERAL

US STATE DEPARTMENT  
BUREAU OF OVERSEAS BUILDINGS OPERATIONS

LOCATION  
**MATAMOROS | MEXICO**

COMPLETED  
**MAY 2019**

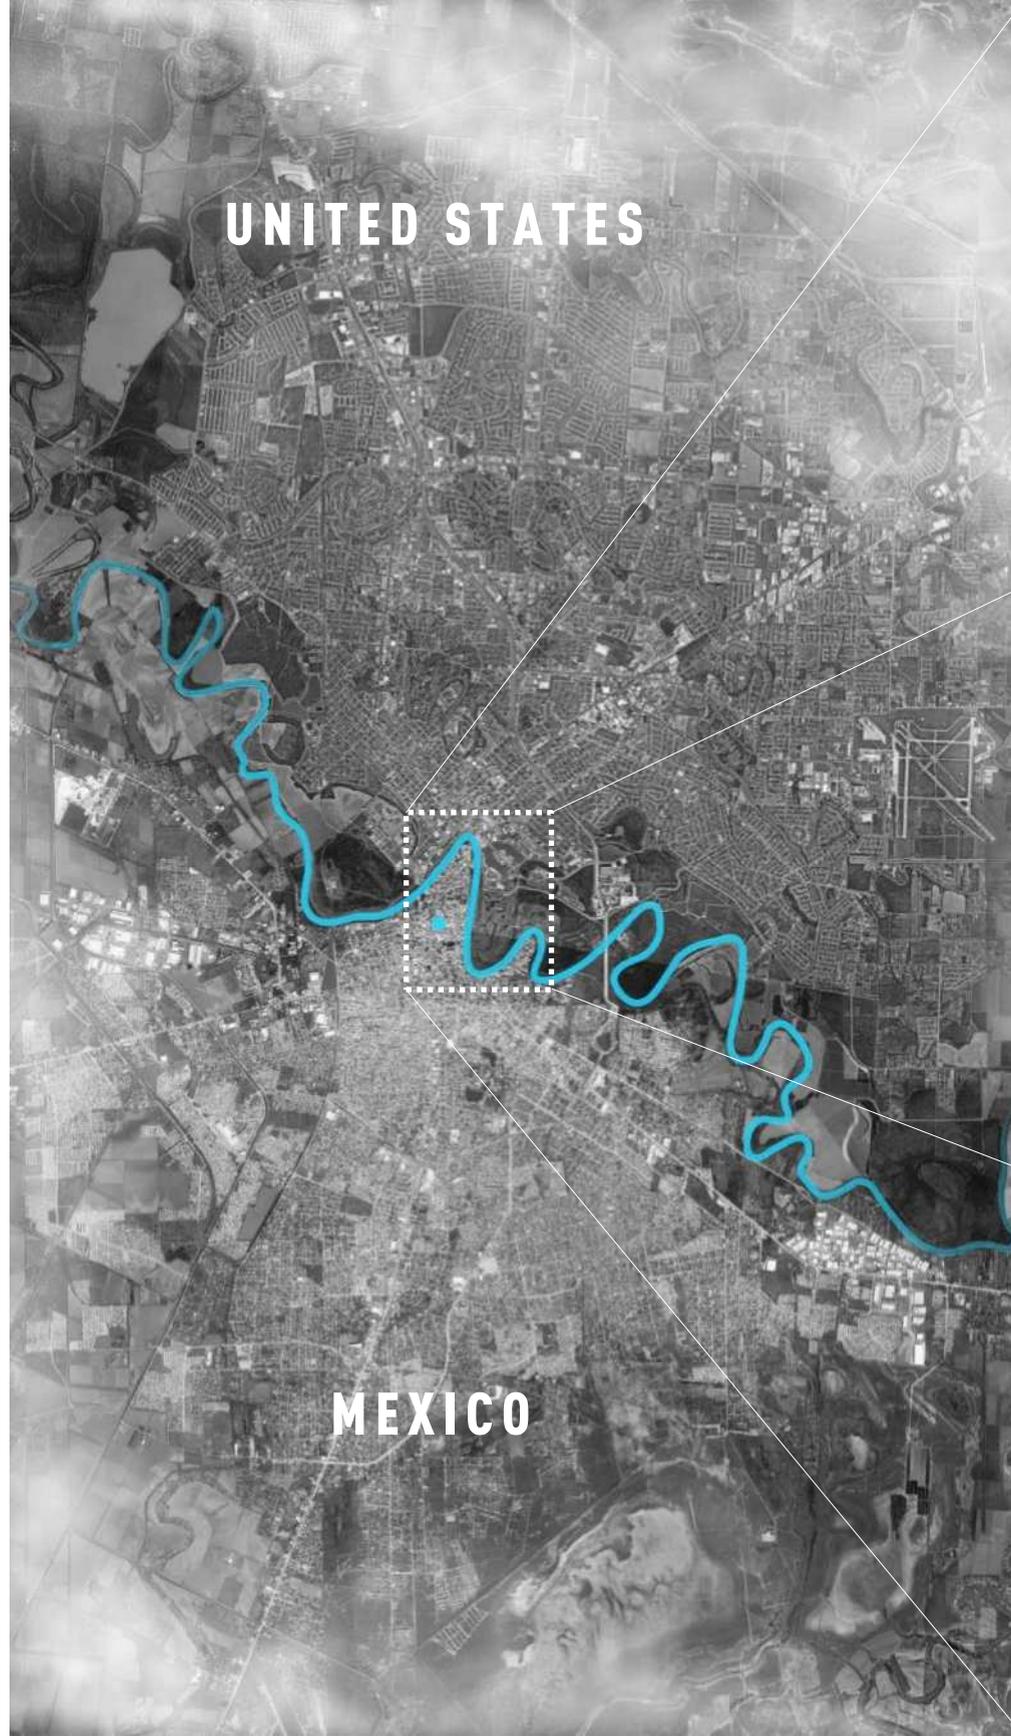
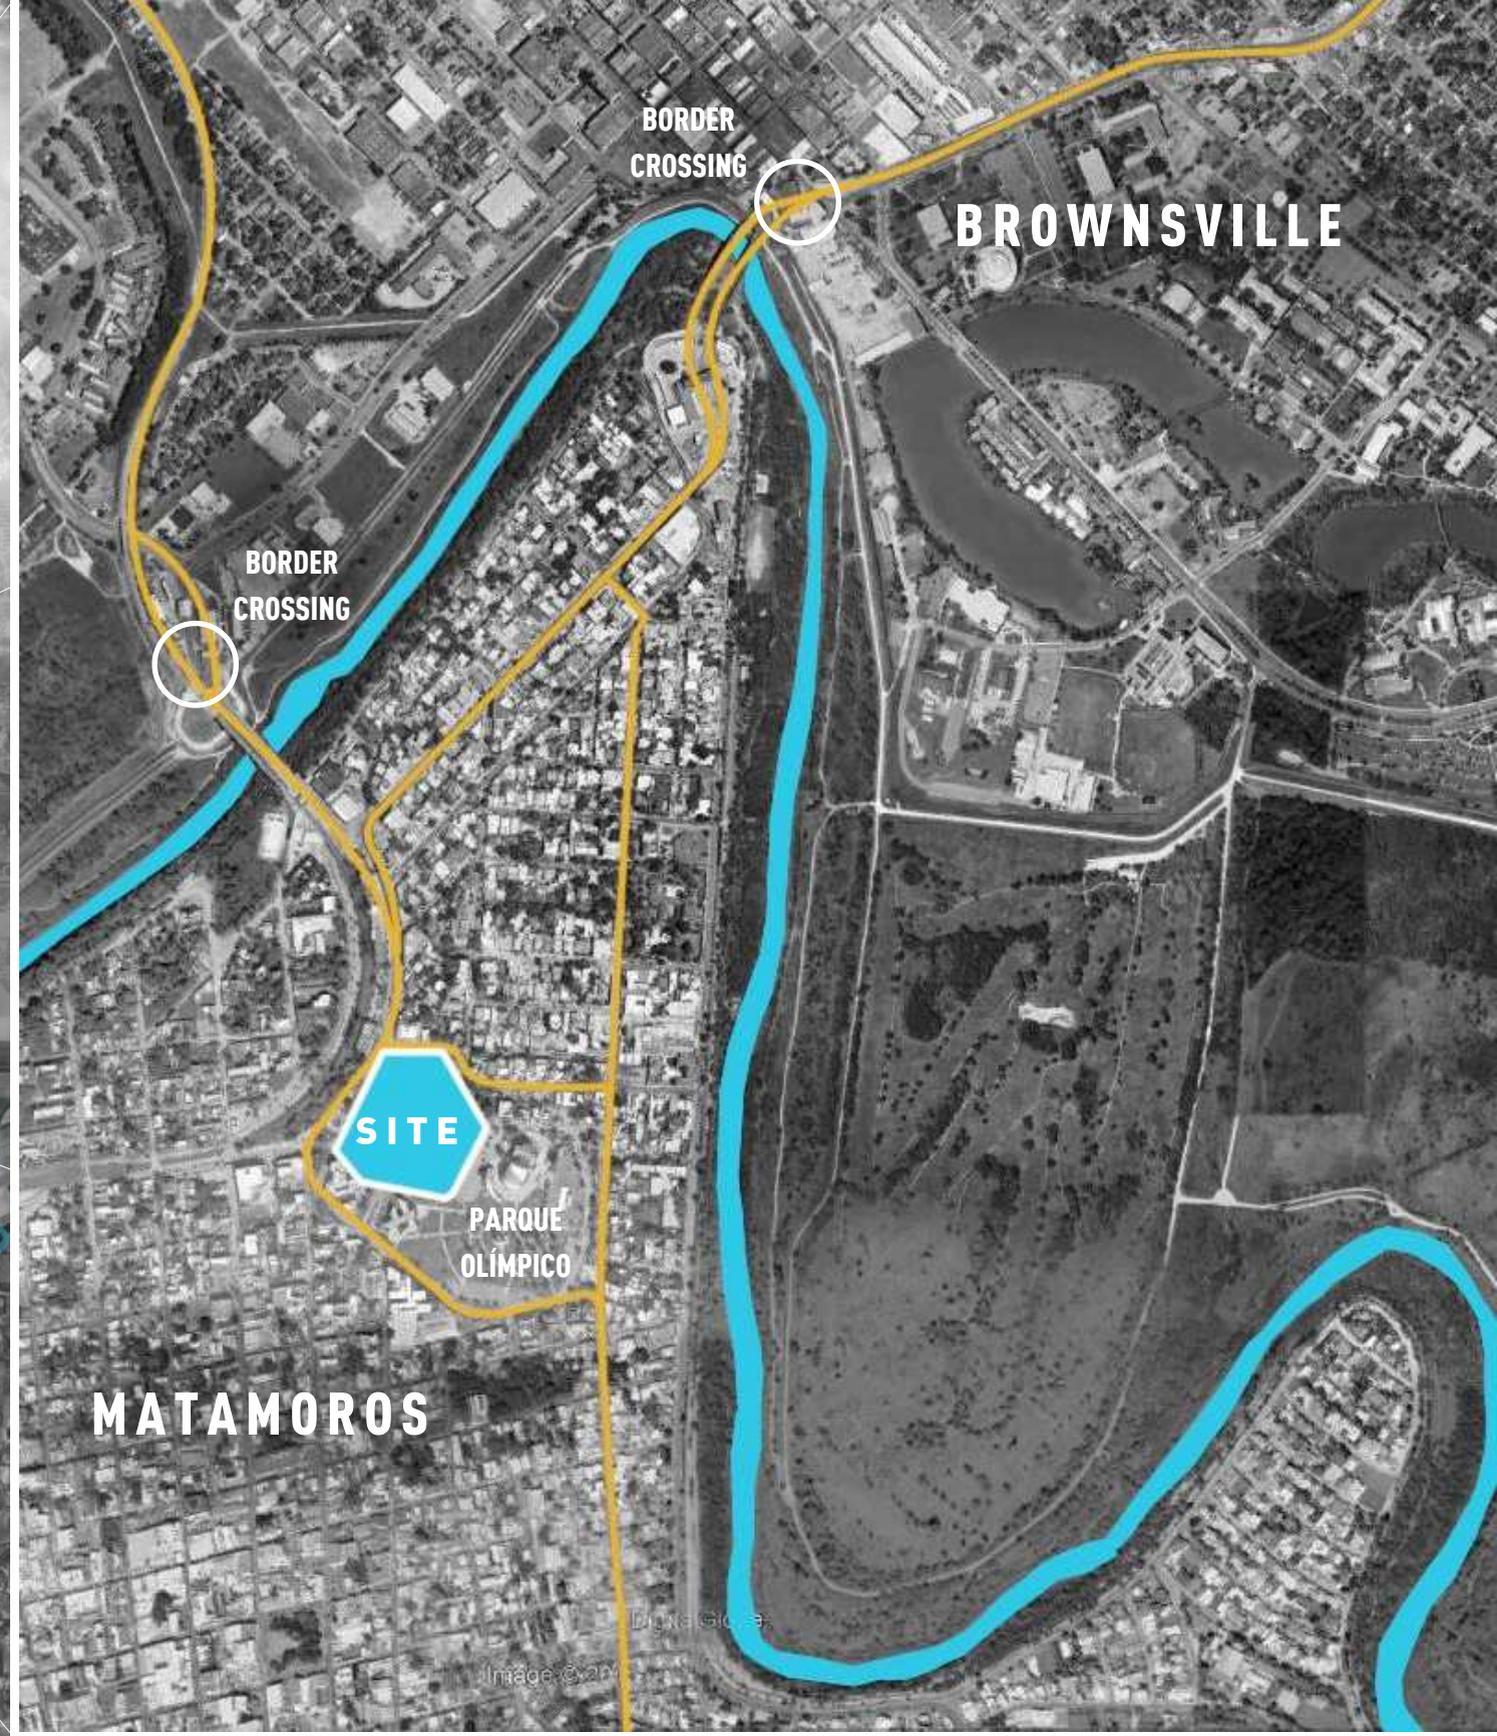
## SITE PLAN

Site planning reflects the primary function as a diplomatic mission with its representational face towards the main roadway, and the consular face (with its receptive edge) towards the community park.

The site is further subdivided with public and representational functions along the north and northeastern street edges, and service functions organized along its southern edge.

These two axes define the campus organization - the primary east/west representational and secondary north/south functional.

The heavy demand on consular services drives a prominent entry location - identifiable from street edges and permitting easy pedestrian and bus traffic.

1. MAIN ENTRY PAVILION
2. PARKING
3. NEW CONSULATE BUILDING
4. CONSULAR ENTRY PAVILION
5. RESIDENTIAL
6. RECREATIONAL AREA
7. SUPPORT BUILDING
8. SERVICE ENTRY

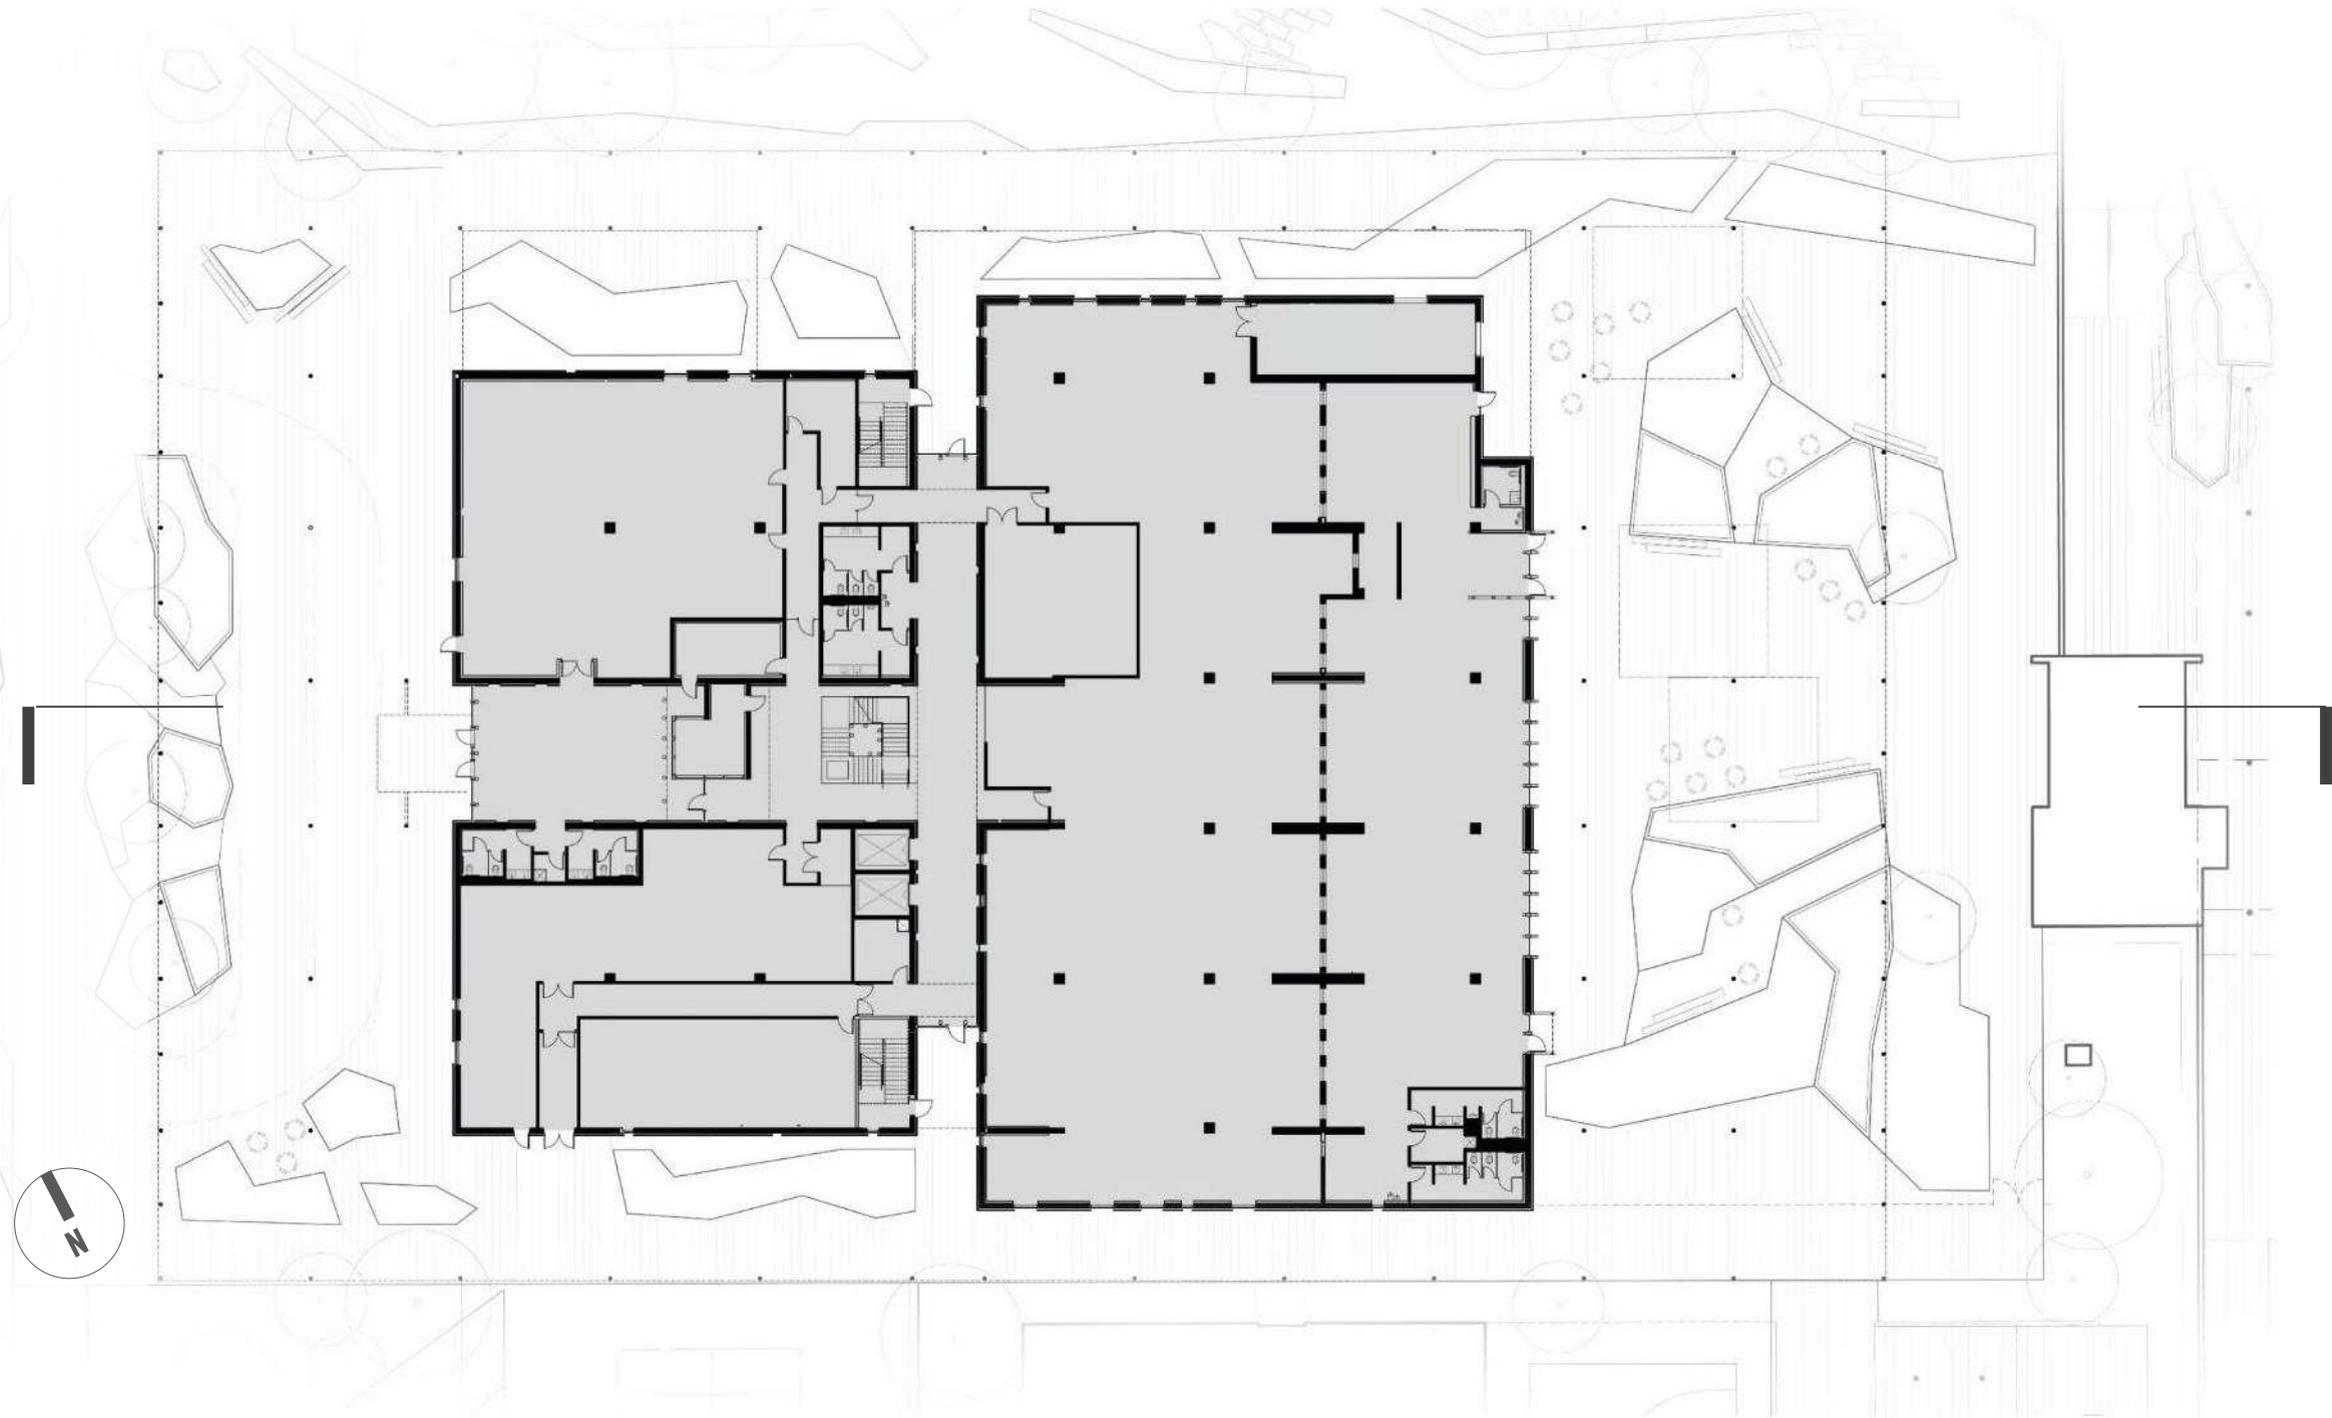
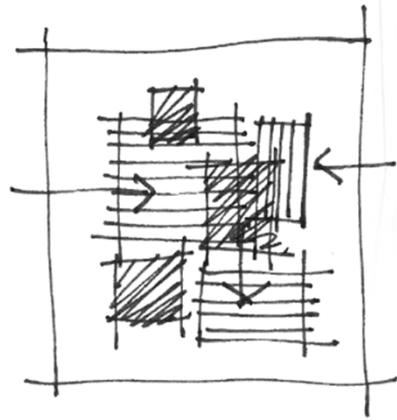
TYPICAL FLOOR PLAN

The form of the building is driven by internal function which provides a compact, economical and secure environment for the building occupants. The compact singular form expresses the separate functional quadrants between the primary gallery and the secondary circulation axis. This organization allows for the required separation of public and secure areas.

PLAN + SECTION

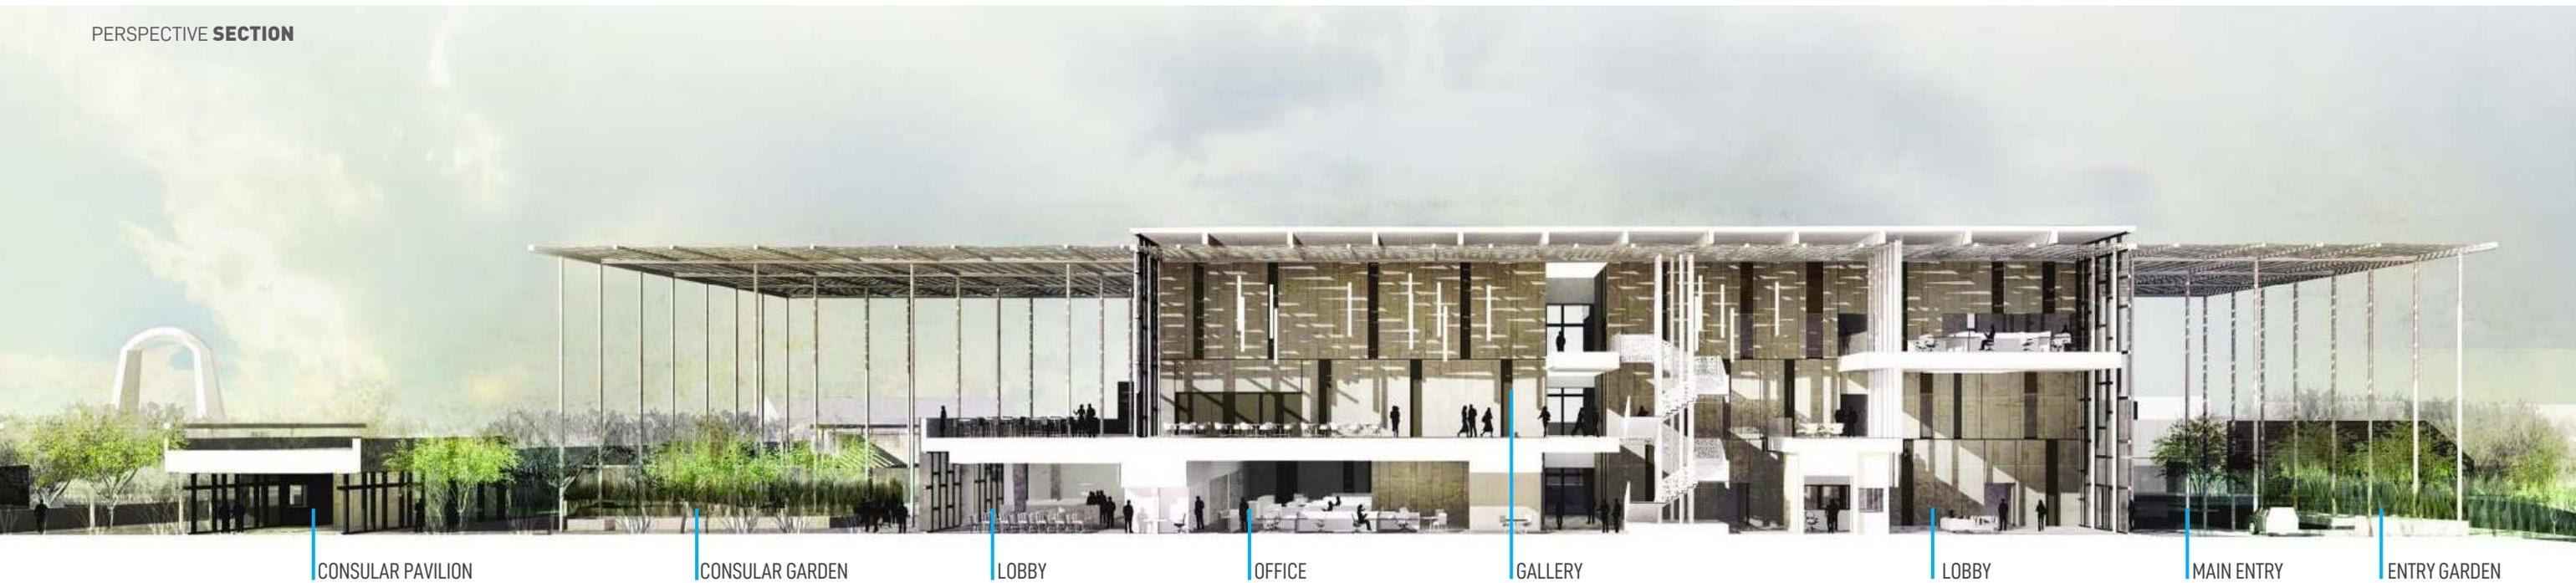
## LATILLA

Heat and intense sun are fundamental to the way of life in Matamoros. Compact and closely-knit urban patterns are linked by tree shaded paseos and courtyards. Interior/exterior relationships are blurred by intervening exterior space. The architectural response is one of functional simplicity and earnestness.

The latilla visually echoes the colonnaded entrances of traditional Beaux-Arts government buildings. The colonnade is a reinterpretation of the classical staccato rhythm and geometry of columns on civic buildings in the United States. The design moderates the interstitial space between the building and the perimeter: creating a permeable extension of program space, extending the building into the conversation with its context.

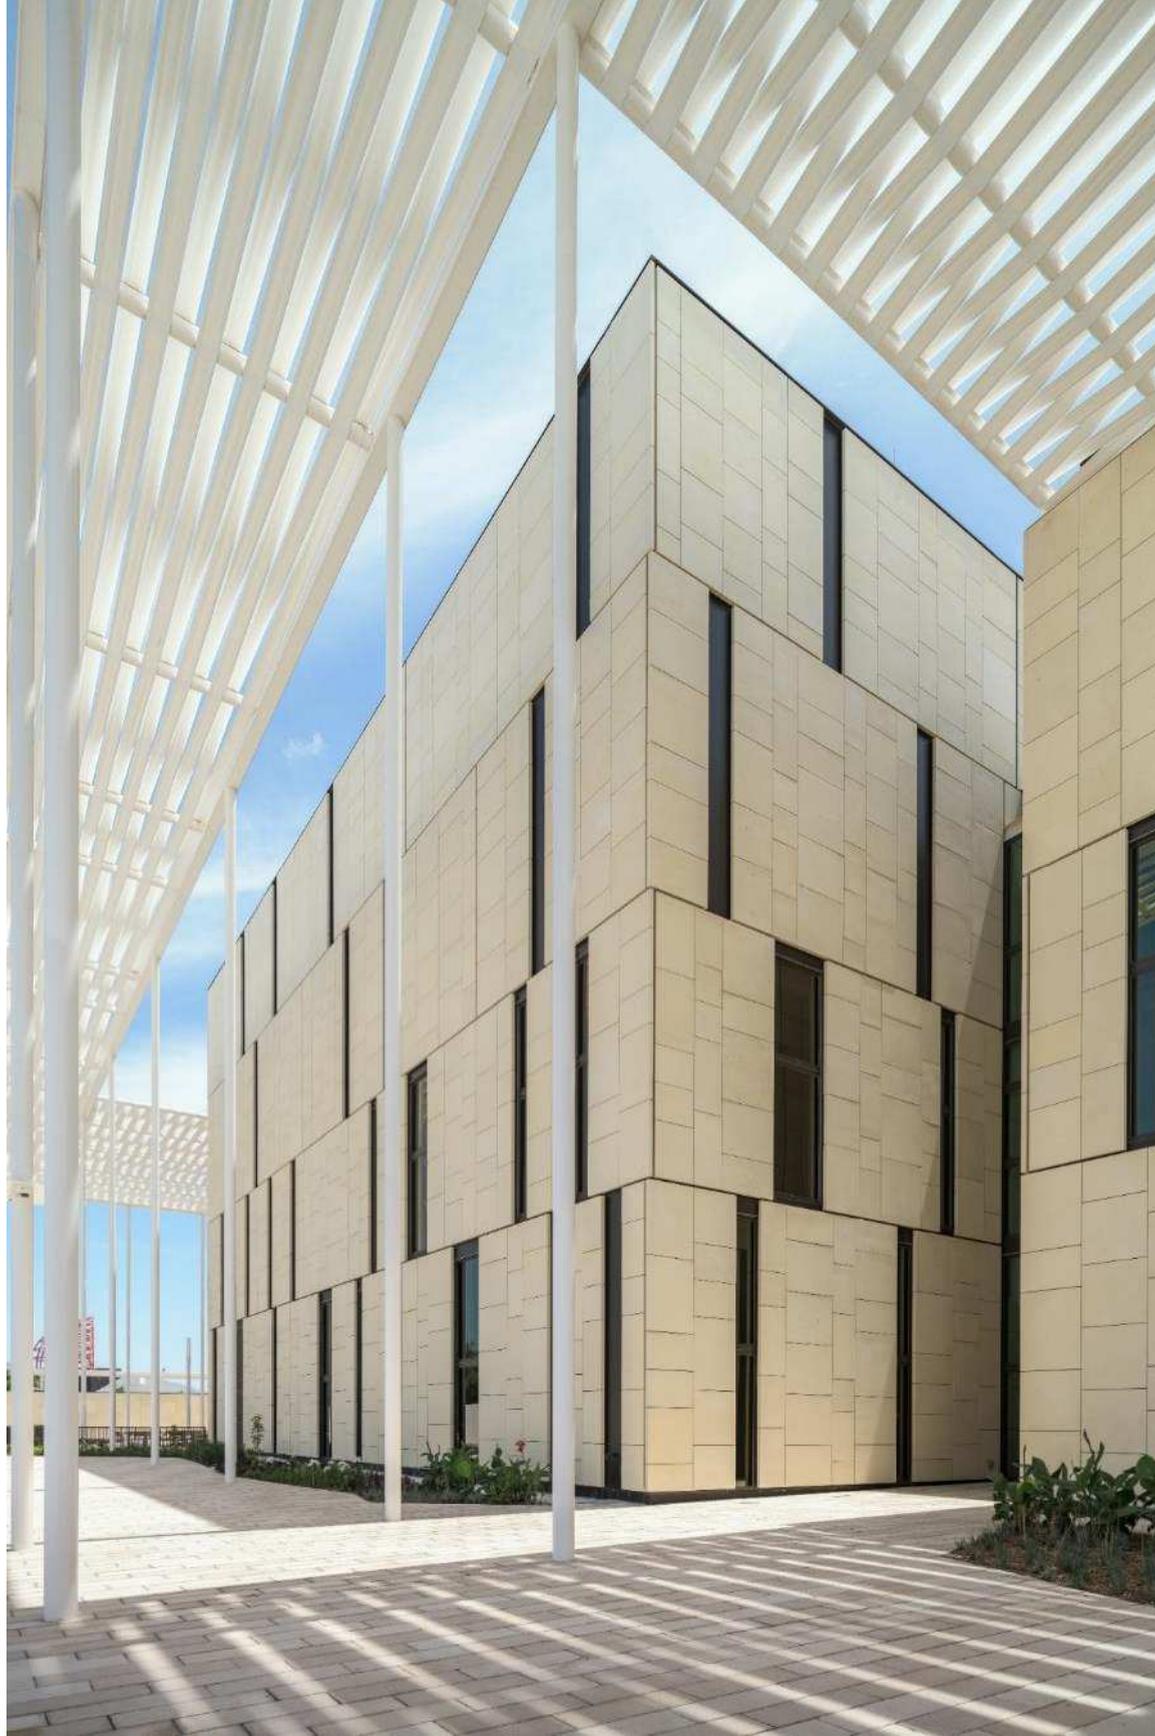
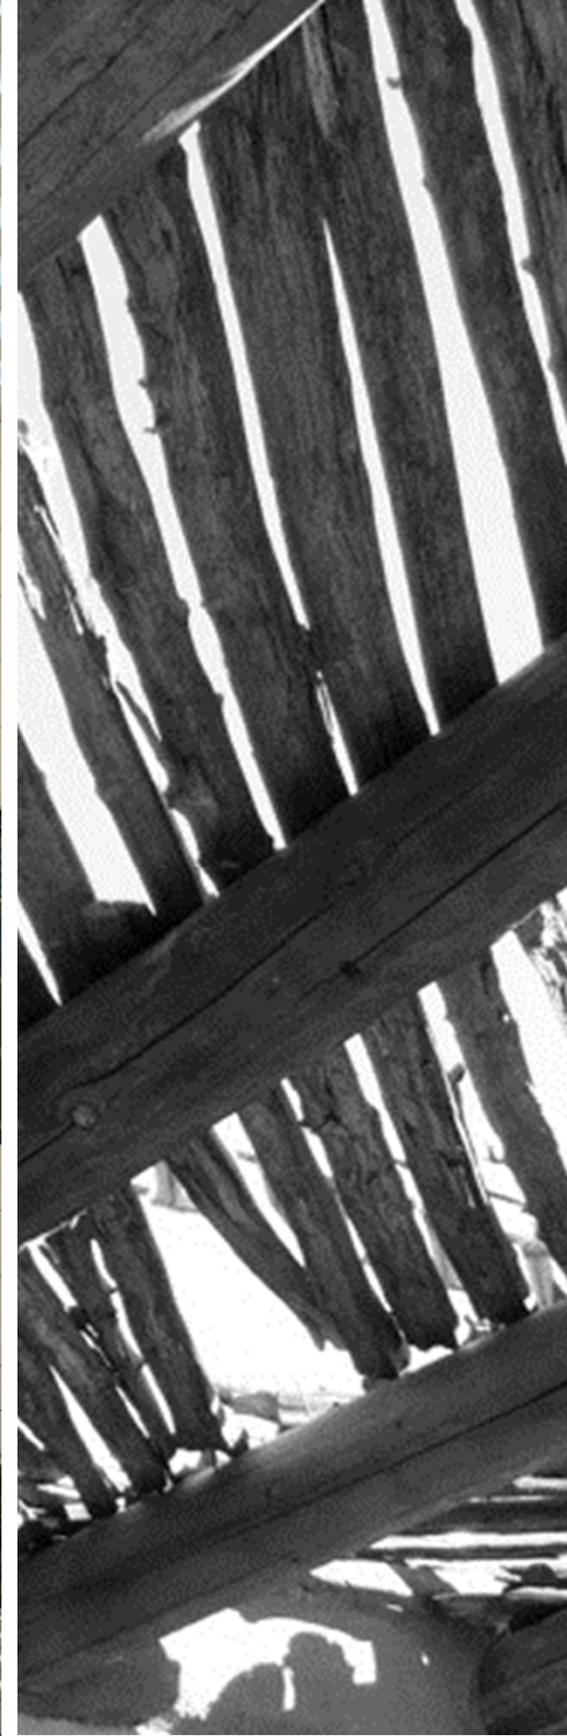
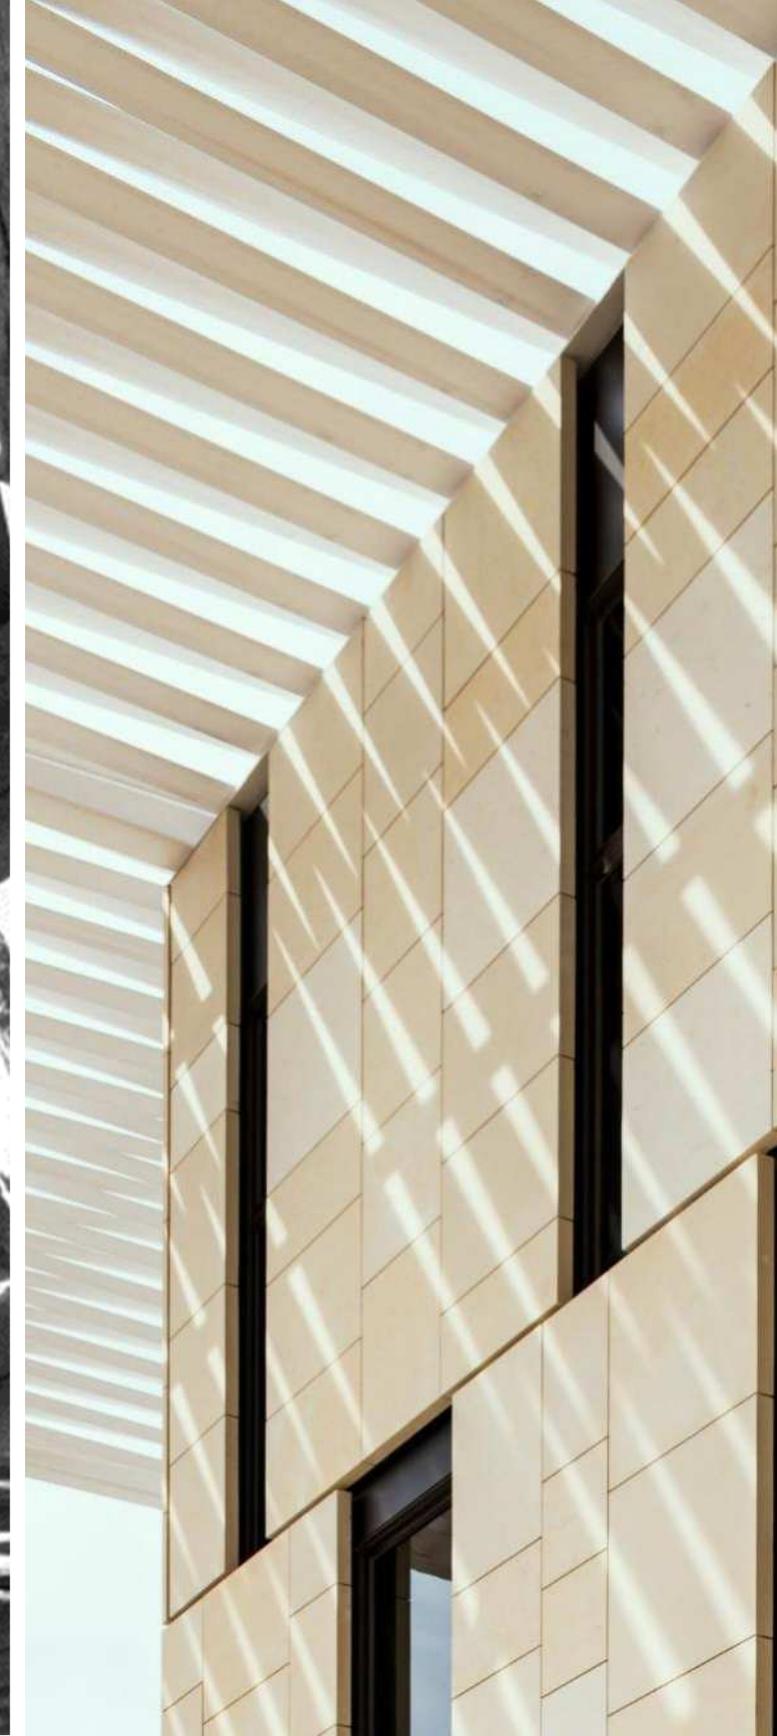
## SHADE

The PTFE fabric panels of the latilla play an important role in improving the energy performance and resiliency. The latilla allows rising heat to pass through, while reducing solar gain, thus reducing the amount of energy required to cool the buildings. On the north side of the compound, the canopy pulls away from the building, allowing more diffuse natural daylight into the workspaces without meaningfully increasing the solar gain.

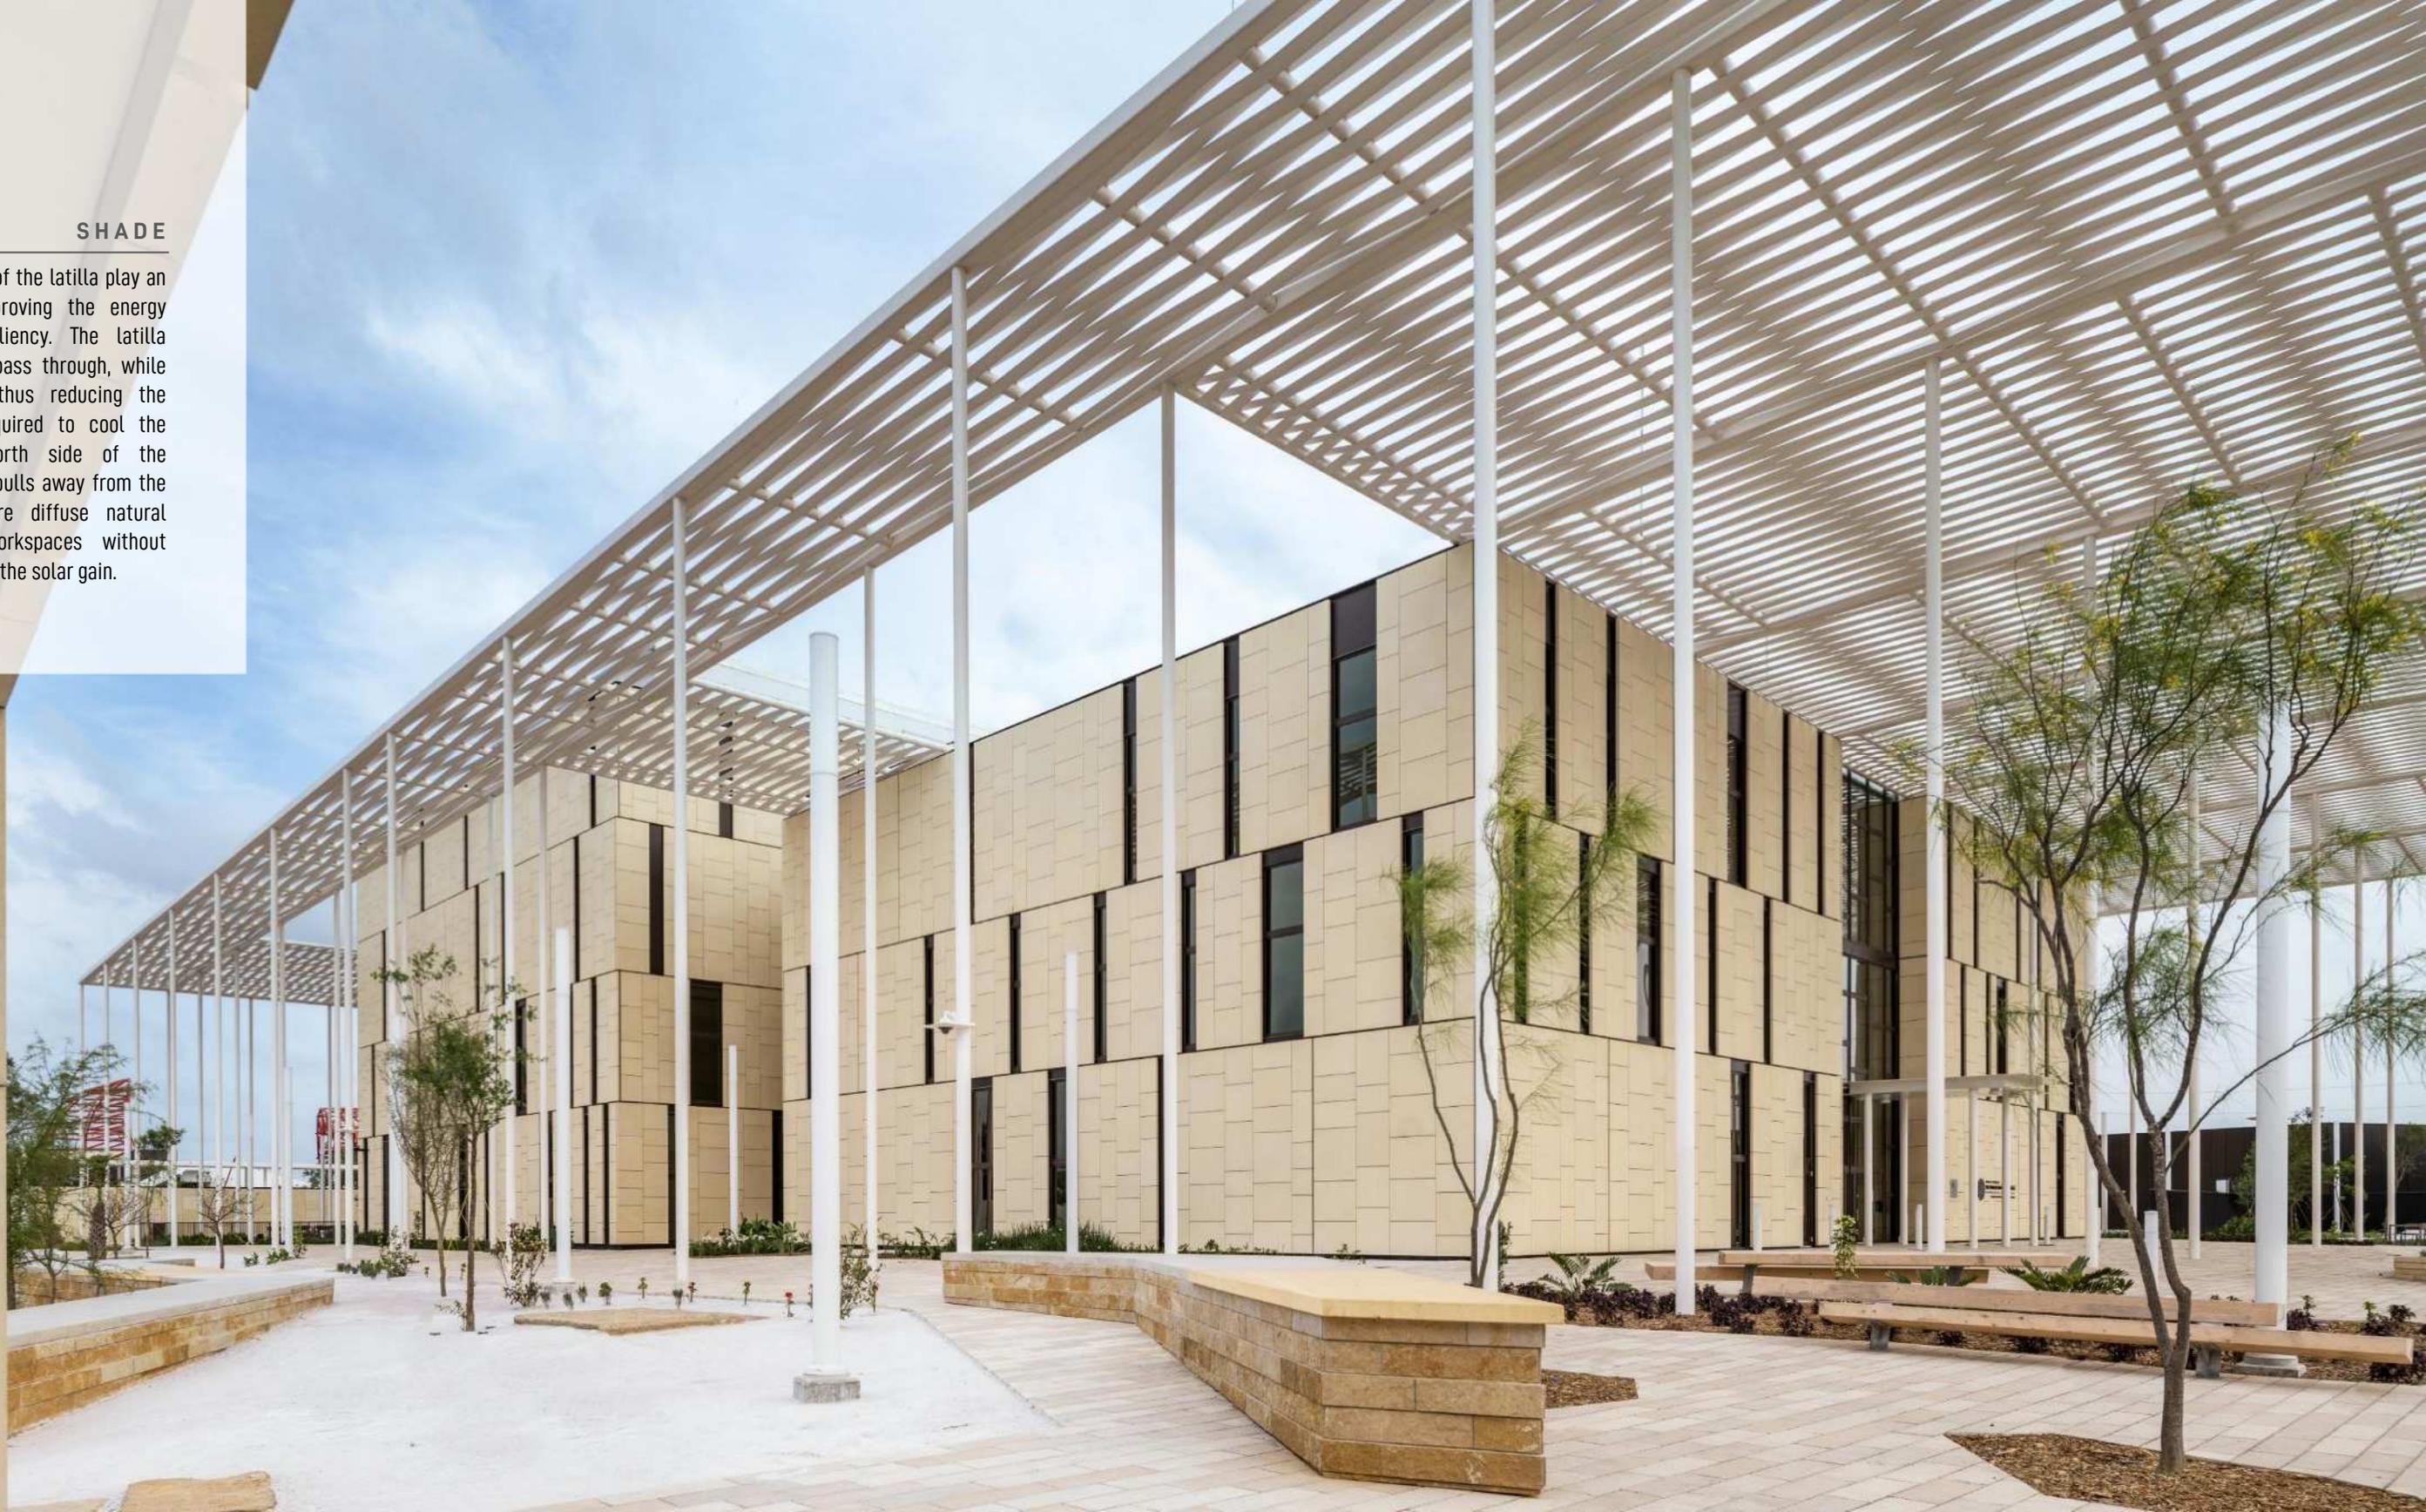
## ARRIVAL

After passing through the main entrance, visitors slowly rise up to the diplomatic entrance court, shaded by the expansive canopy structure. The change in grade provides a natural separation from the traffic at street level, and an ideal location for outdoor events off of the multipurpose room.

In keeping with the context of the city, the materials are simple and robust: cast concrete perimeter walls, a local limestone façade, and dark metal accents. The bright white tubular columns and latilla are inspired by the color of the adjacent amphitheater and library.

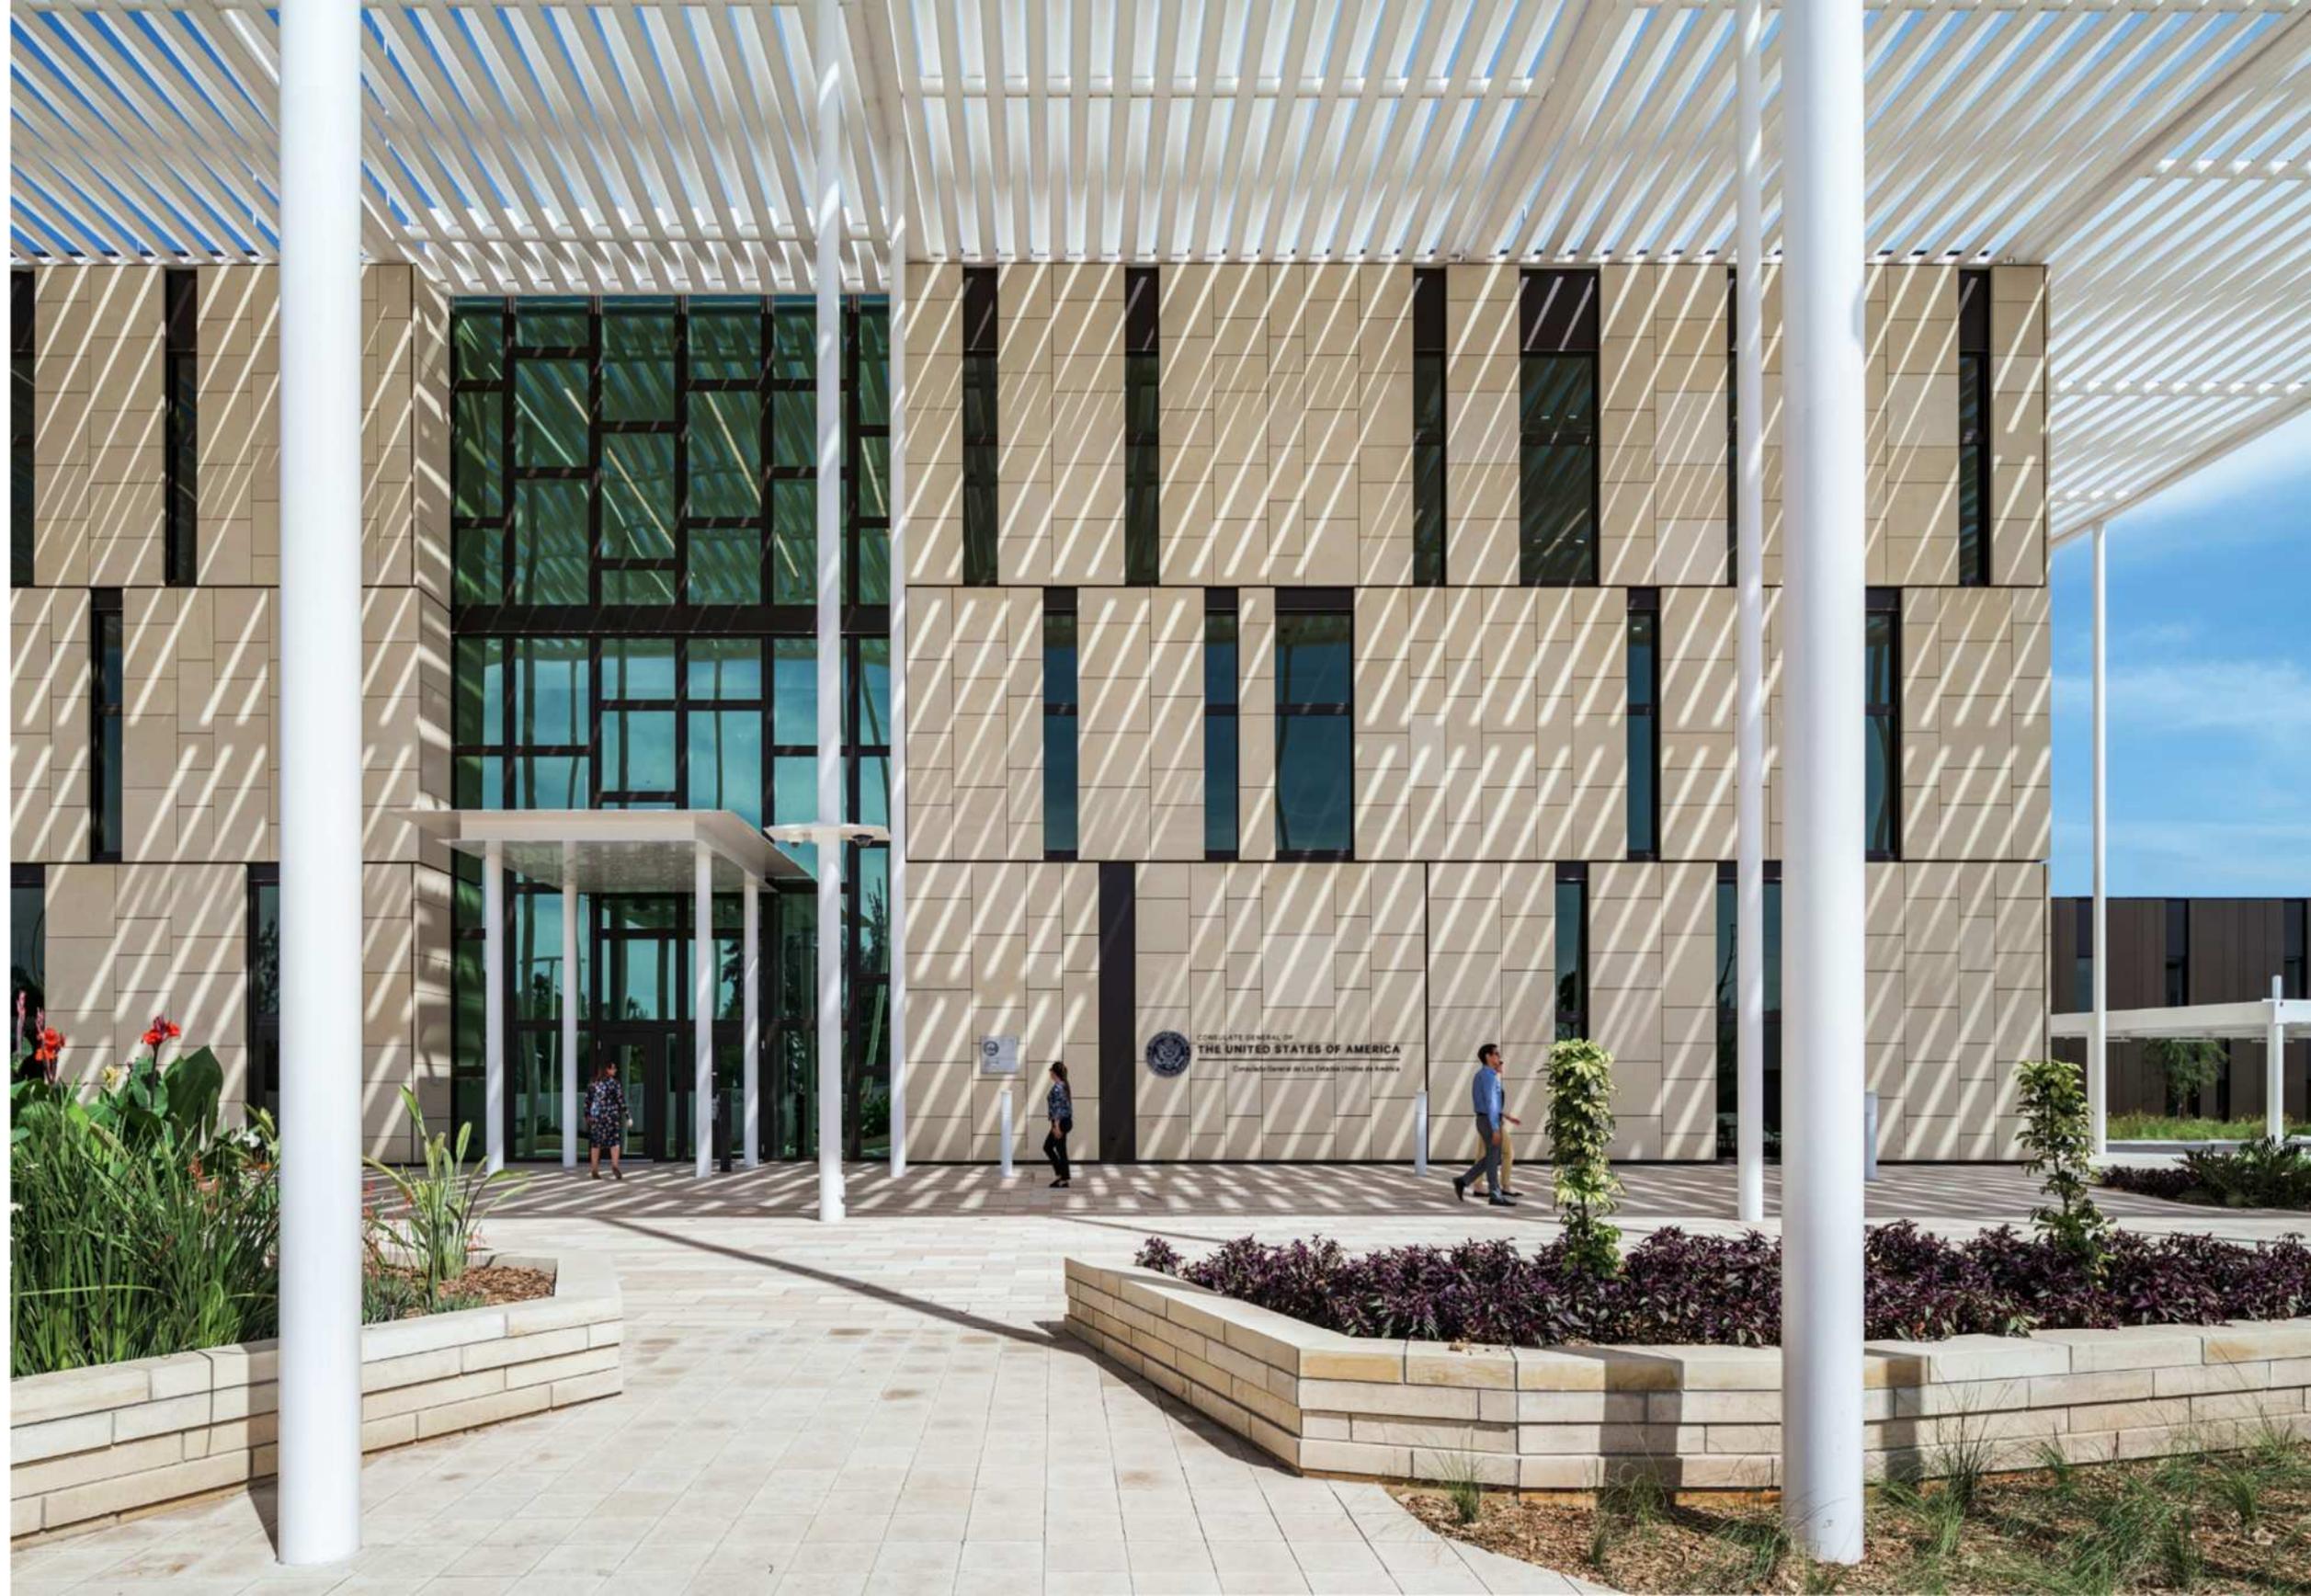
## INTERIOR

A central staircase of perforated metal connects all three levels, which contain open-plan work spaces for over 100 diplomatic staff, as well as a range of conference spaces and private offices

A central gallery unites all three levels of workspace, and is suffused with natural light from clerestory windows.
