# UNITED STATES CONSULATE GENERAL

US STATE DEPARTMENT  
BUREAU OF OVERSEAS BUILDINGS OPERATIONS

LOCATION  
**MATAMOROS | MEXICO**

COMPLETED  
**MAY 2019**

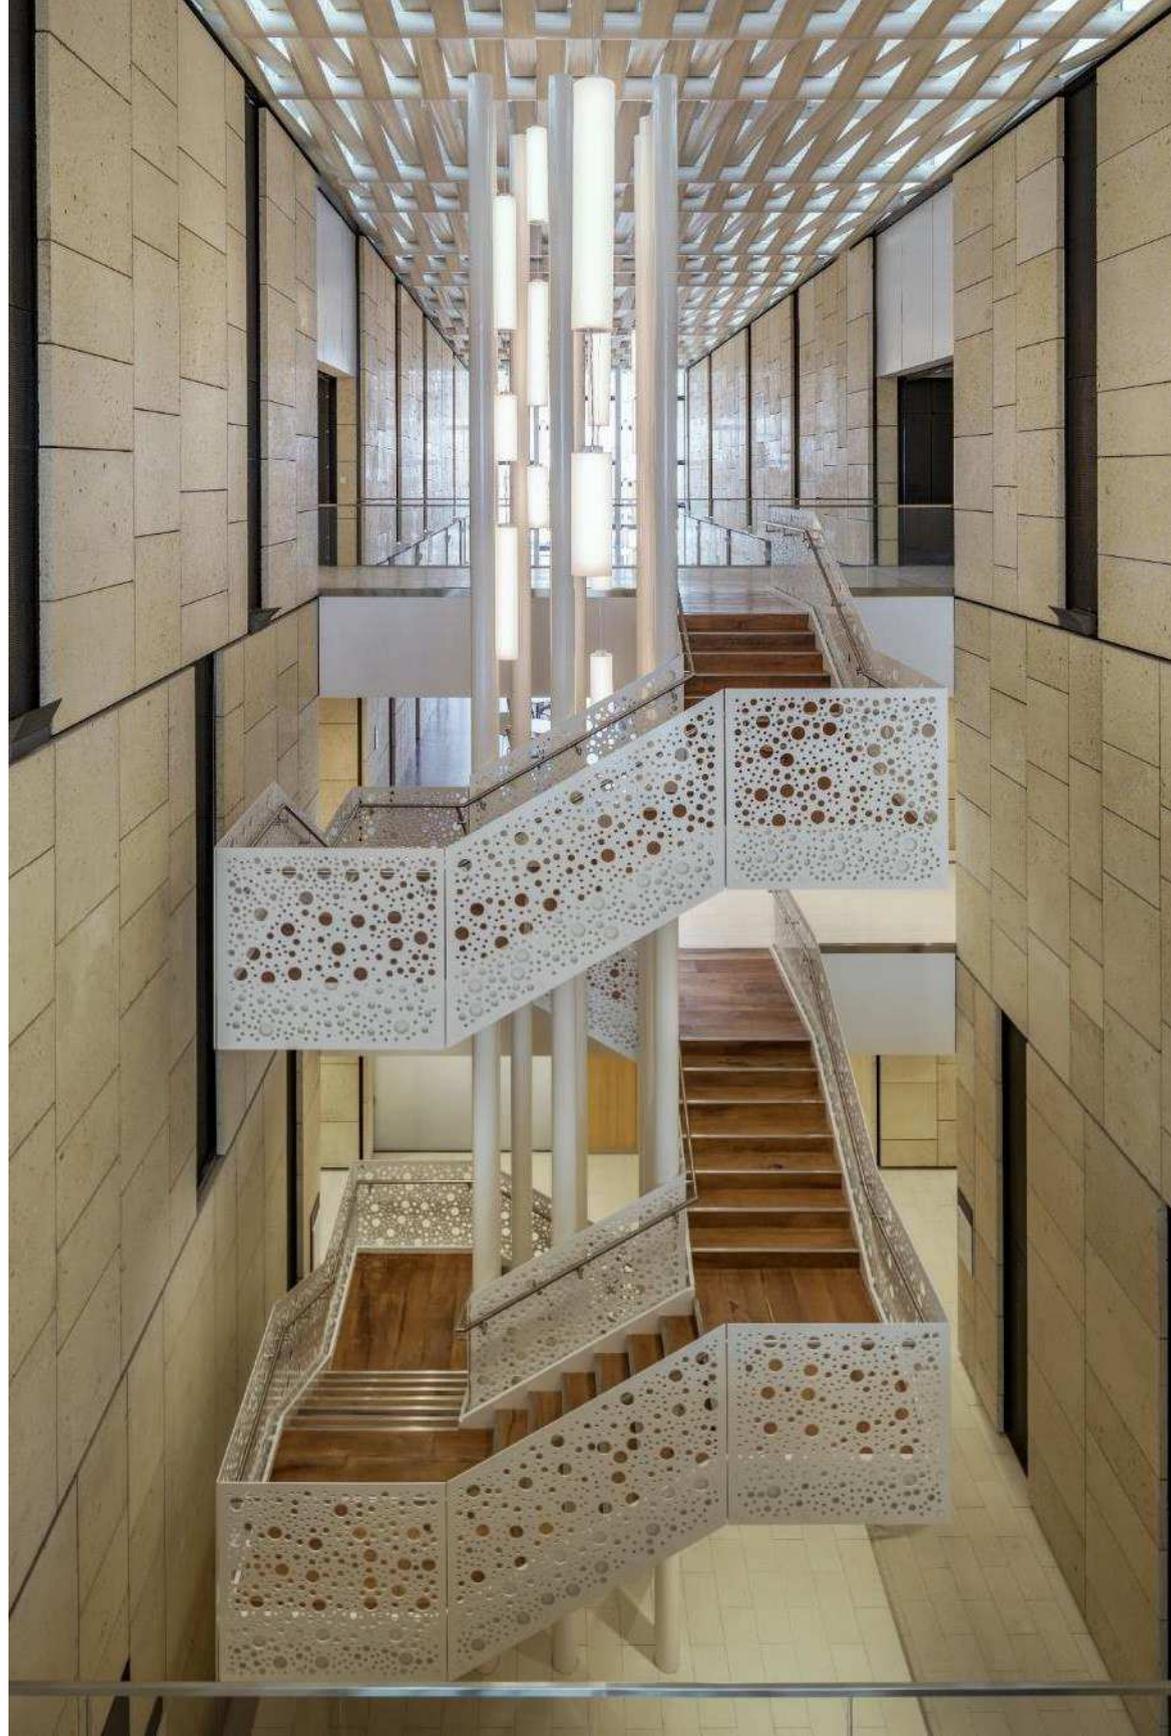
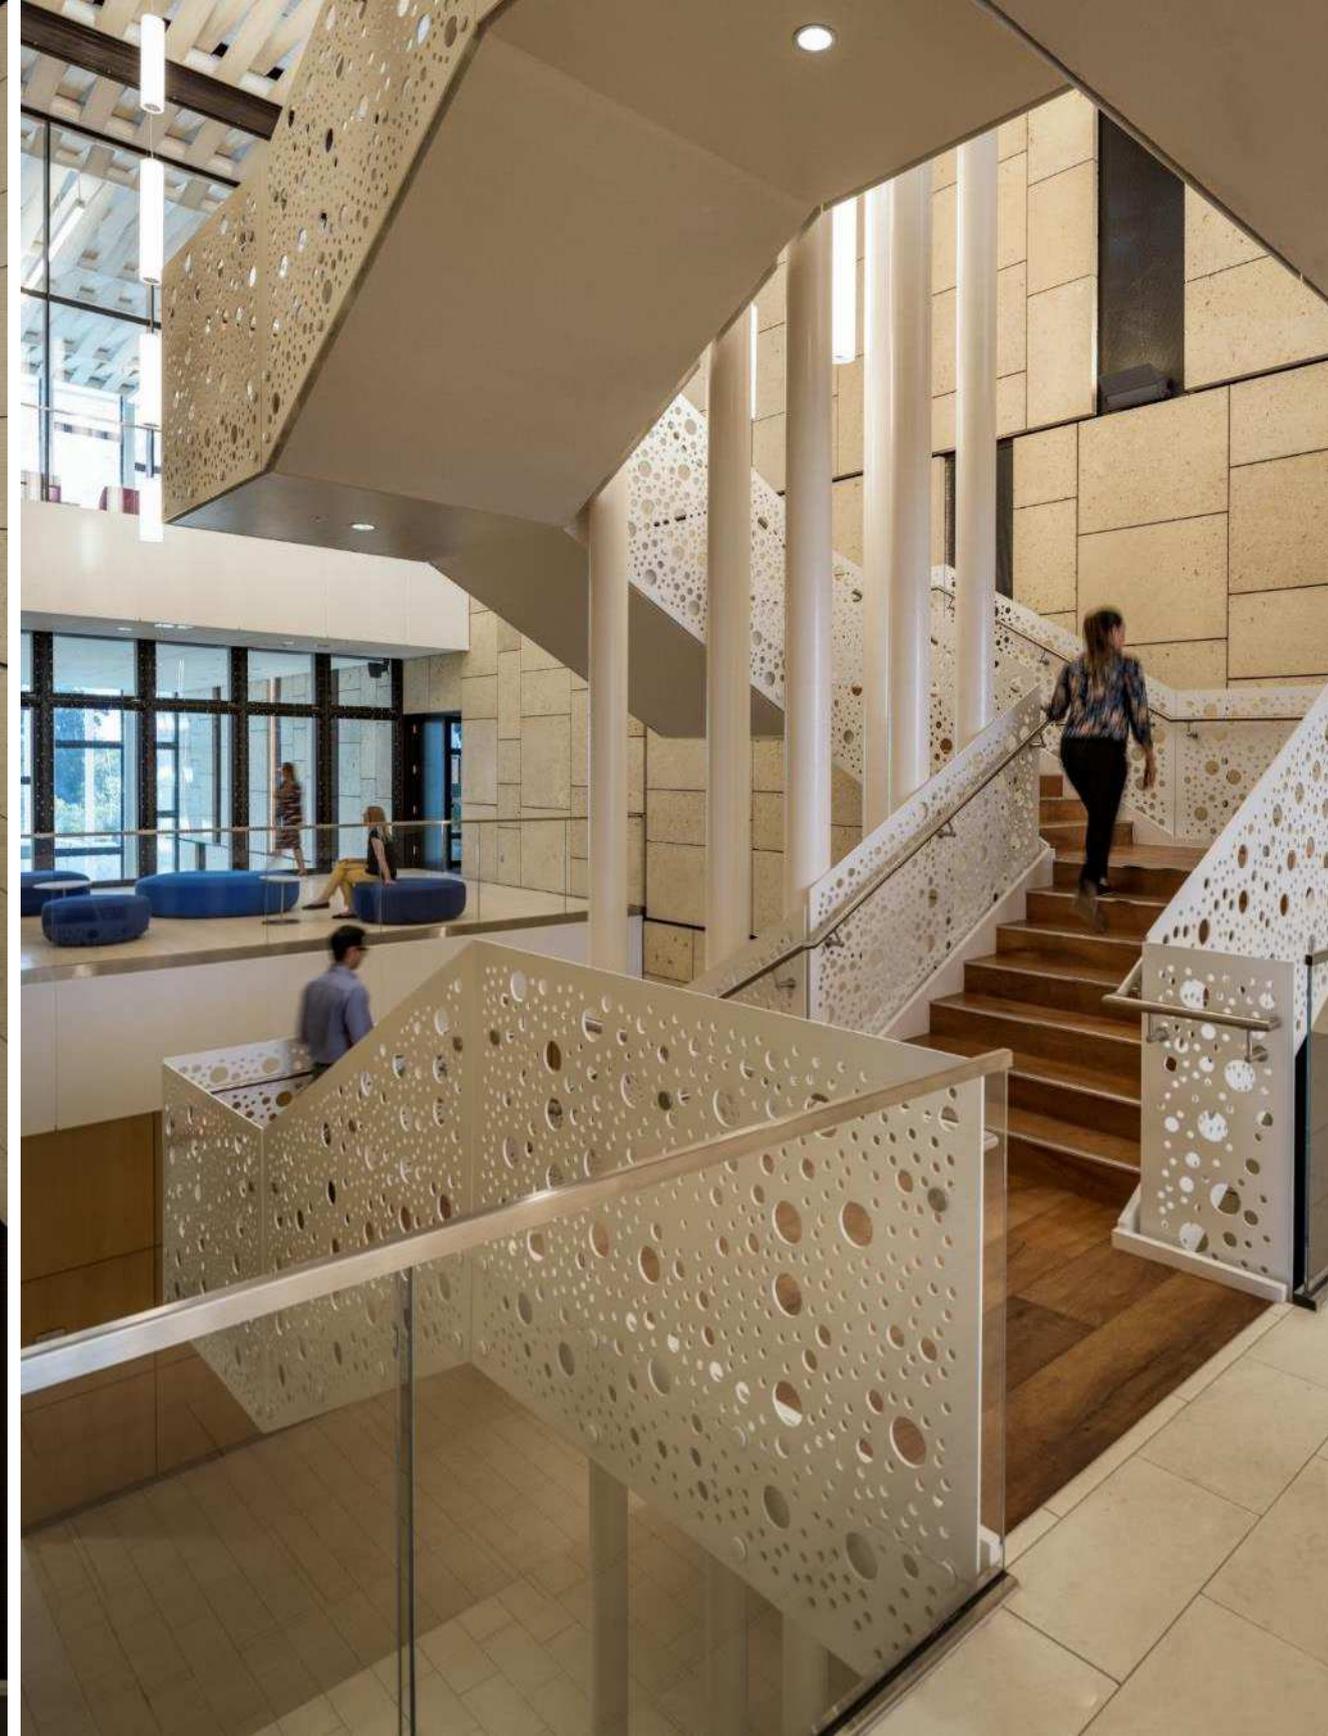
A central staircase of perforated metal connects all three levels, which contain open-plan work spaces for over 100 diplomatic staff, as well as a range of conference spaces and private offices

A central gallery unites all three levels of workspace, and is suffused with natural light from clerestory windows.

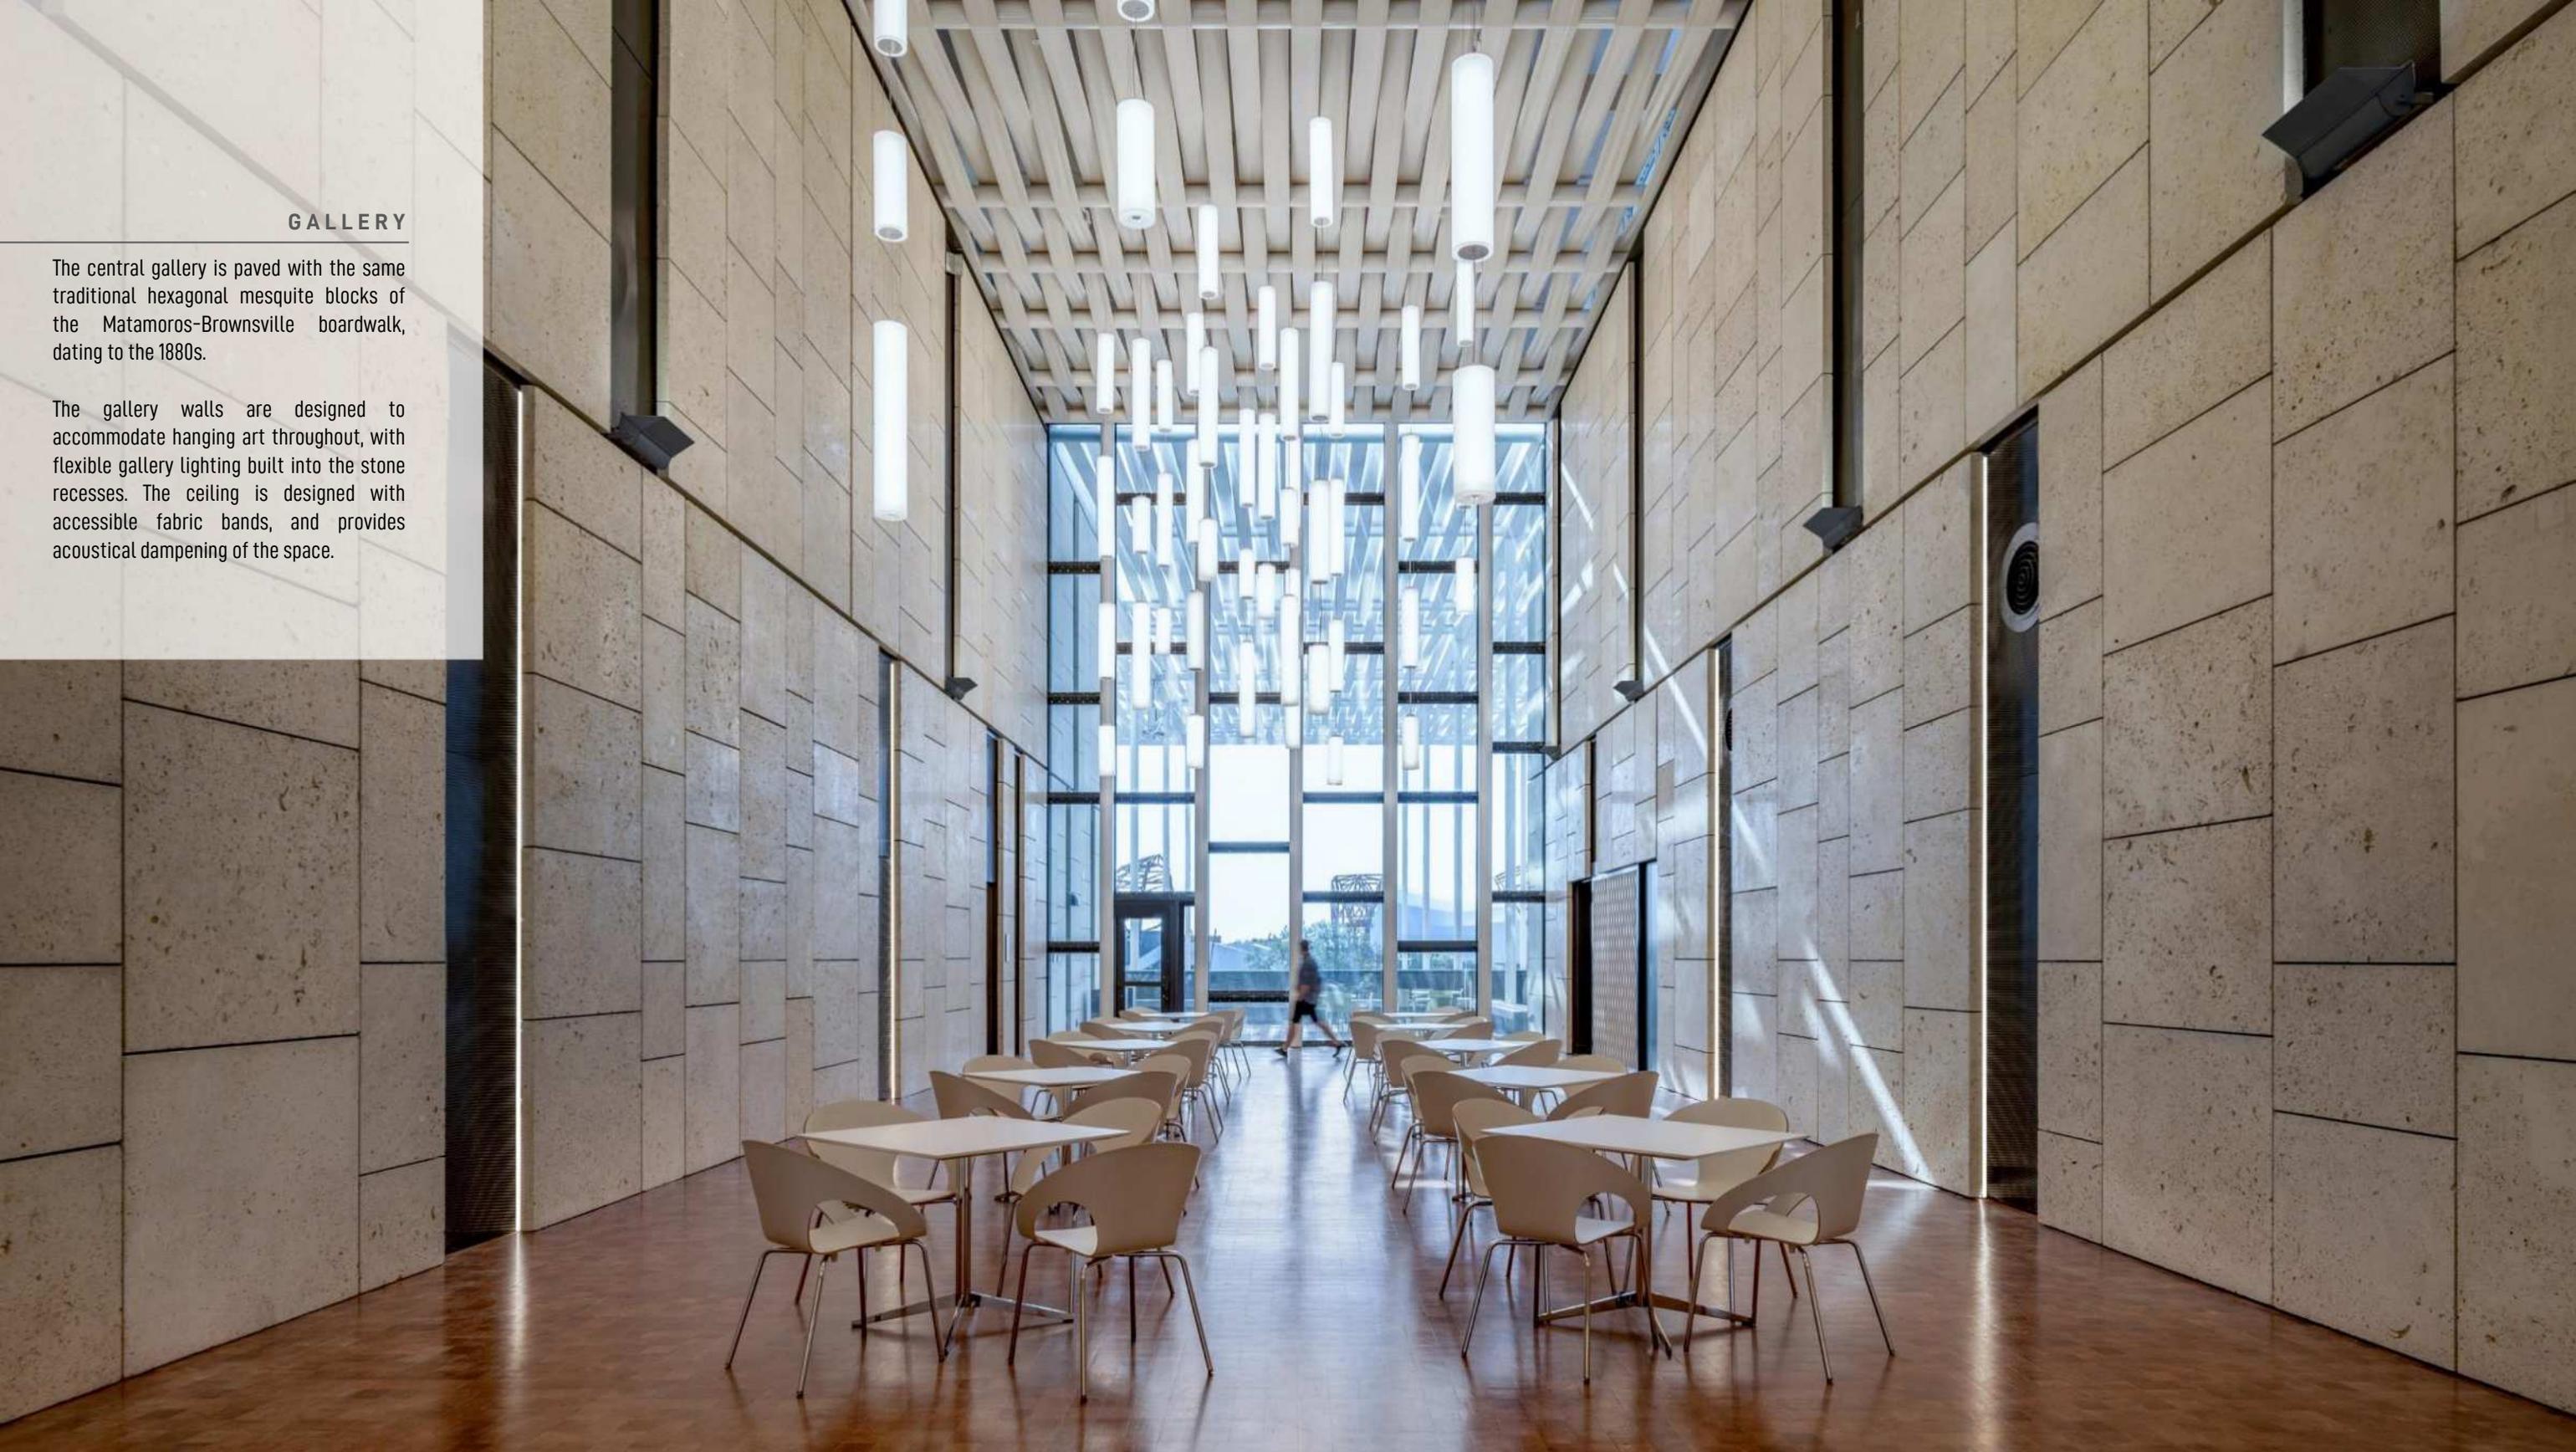
The central gallery is paved with the same traditional hexagonal mesquite blocks of the Matamoros-Brownsville boardwalk, dating to the 1880s.

The gallery walls are designed to accommodate hanging art throughout, with flexible gallery lighting built into the stone recesses. The ceiling is designed with accessible fabric bands, and provides acoustical dampening of the space.

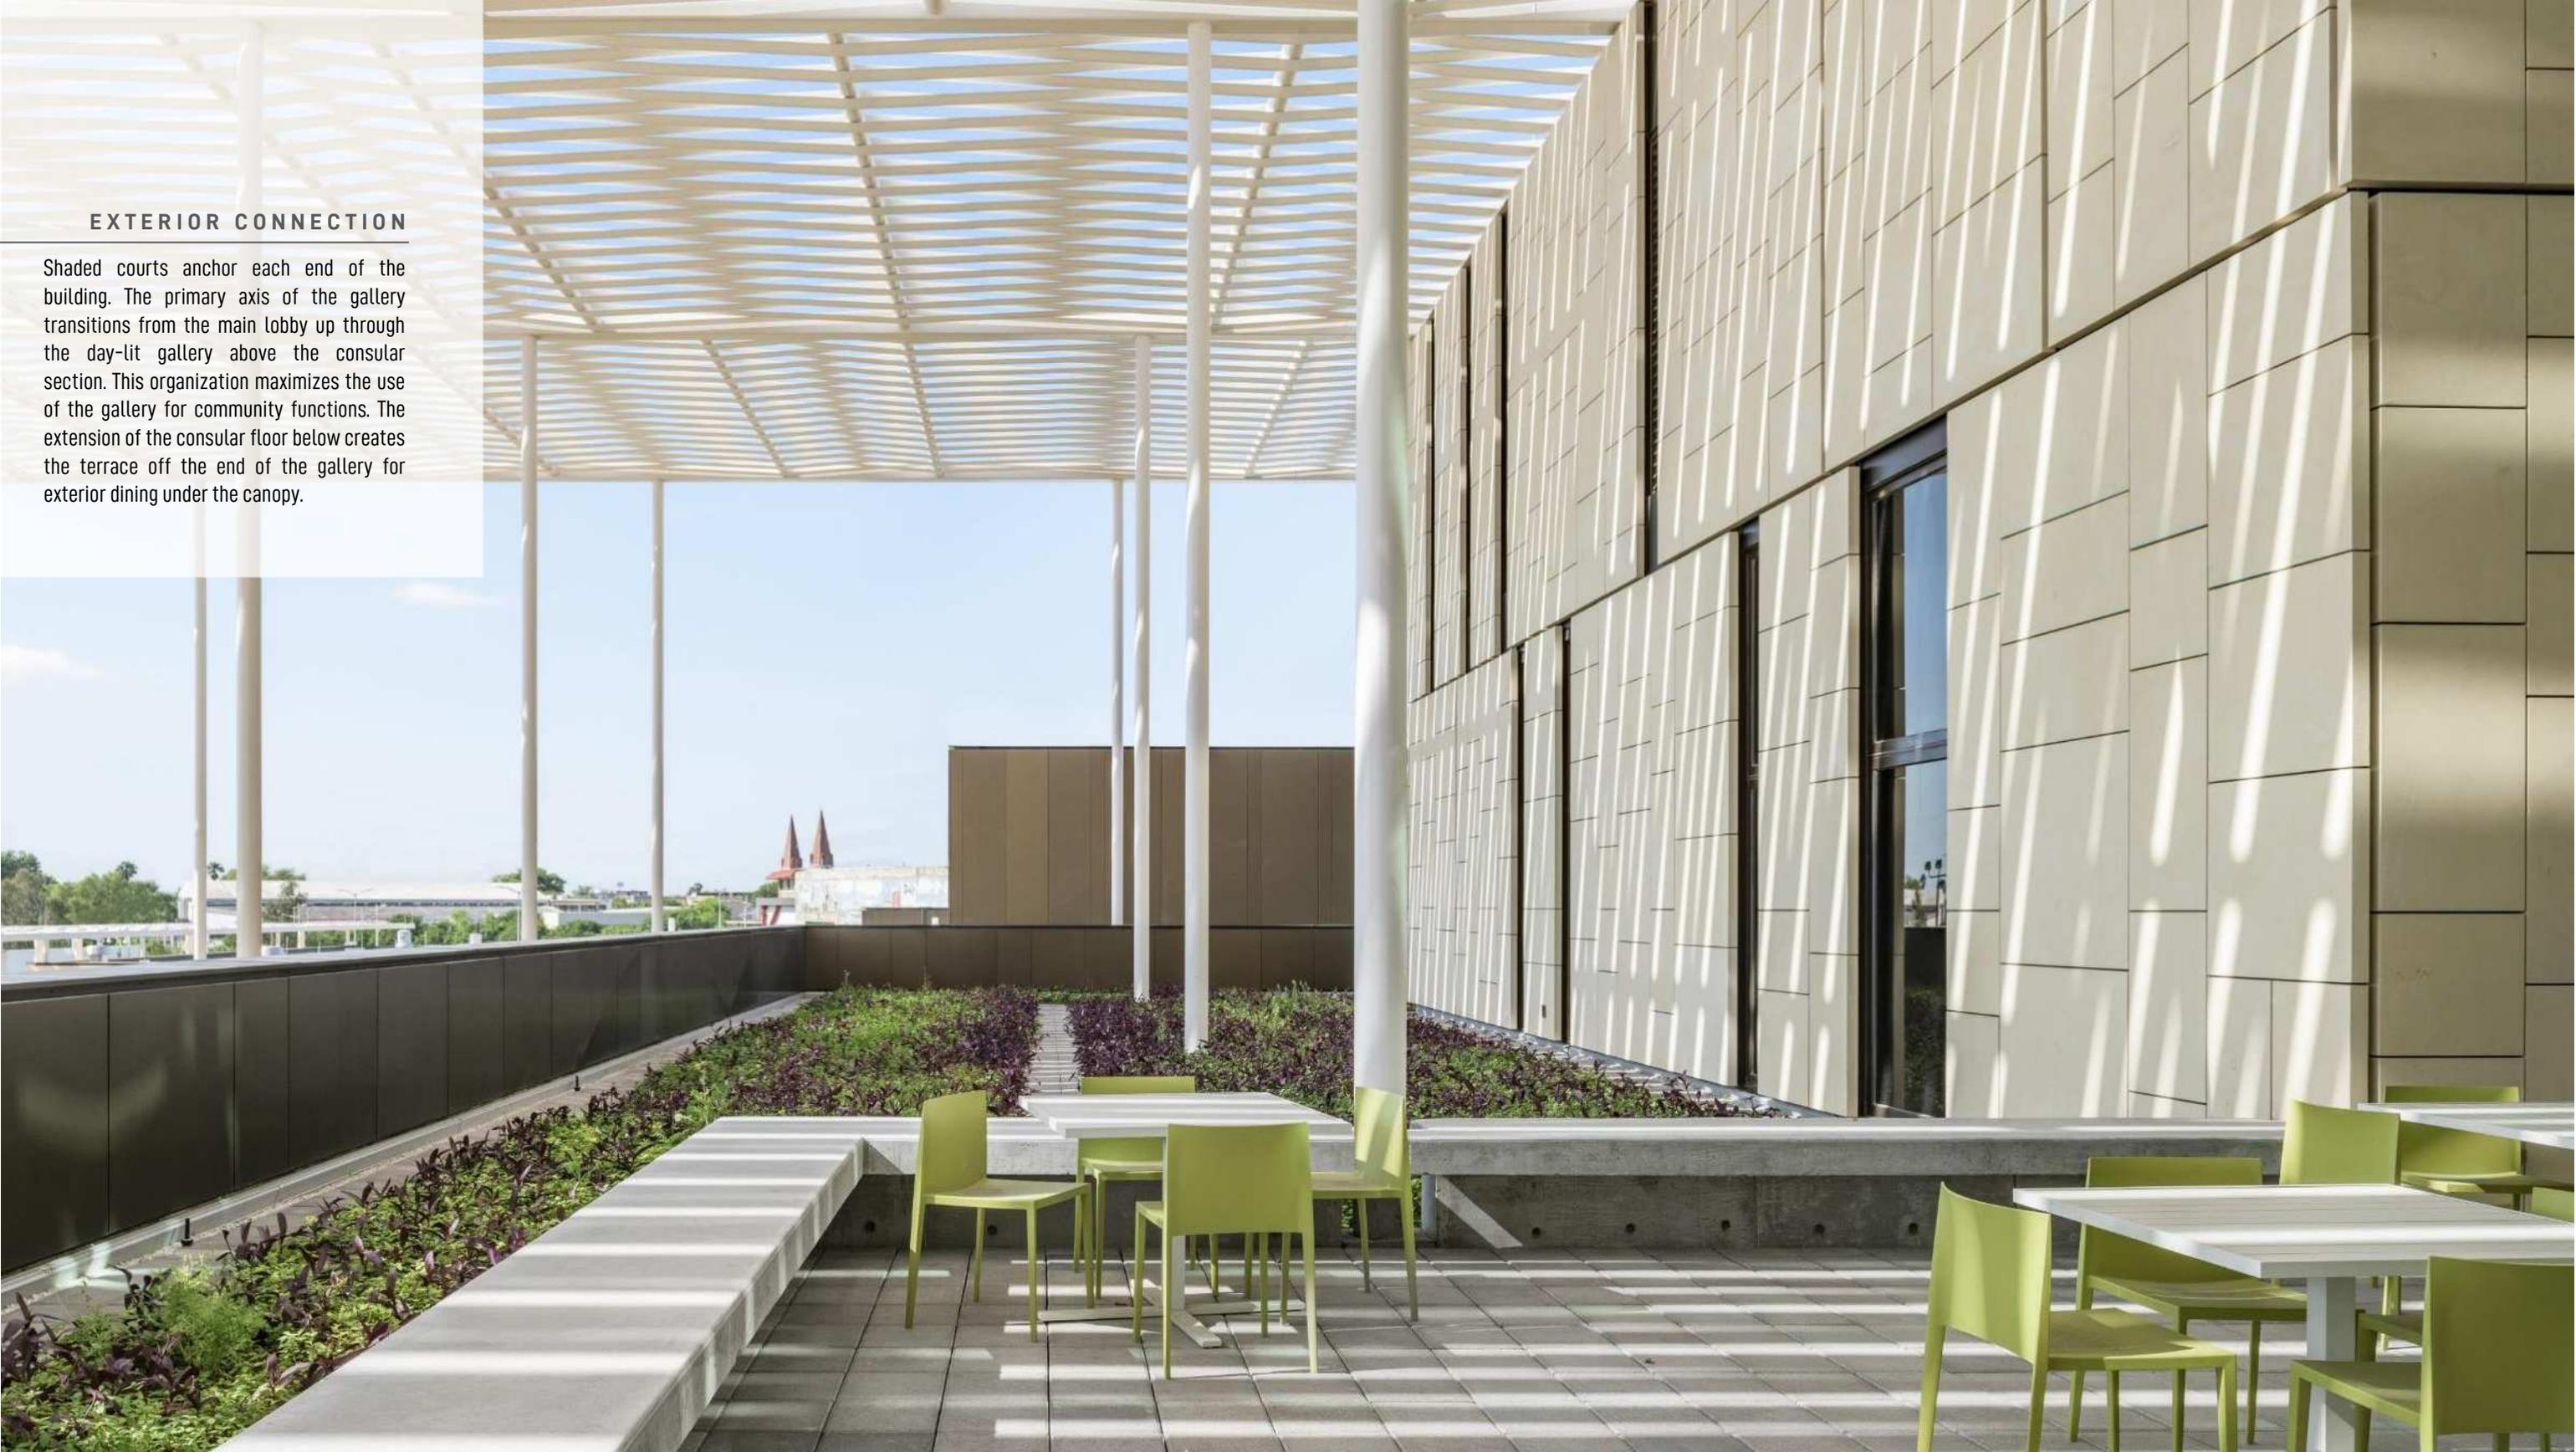
## FLEXIBLE OFFICES

The coral limestone exterior cladding extends inside, and a range of other local materials and references occur throughout the building. Carpet tile in the office spaces references the city's pebble-paved pathways.

Site lines between individuals are maintained by lowering the height of system furniture in open work areas. Work areas utilize a low-profile access floor to maximize future flexibility. Open work areas allow for exchanging of information, decision making and discussion amongst users. Clerestory glass illuminates areas deep into the floorplate.

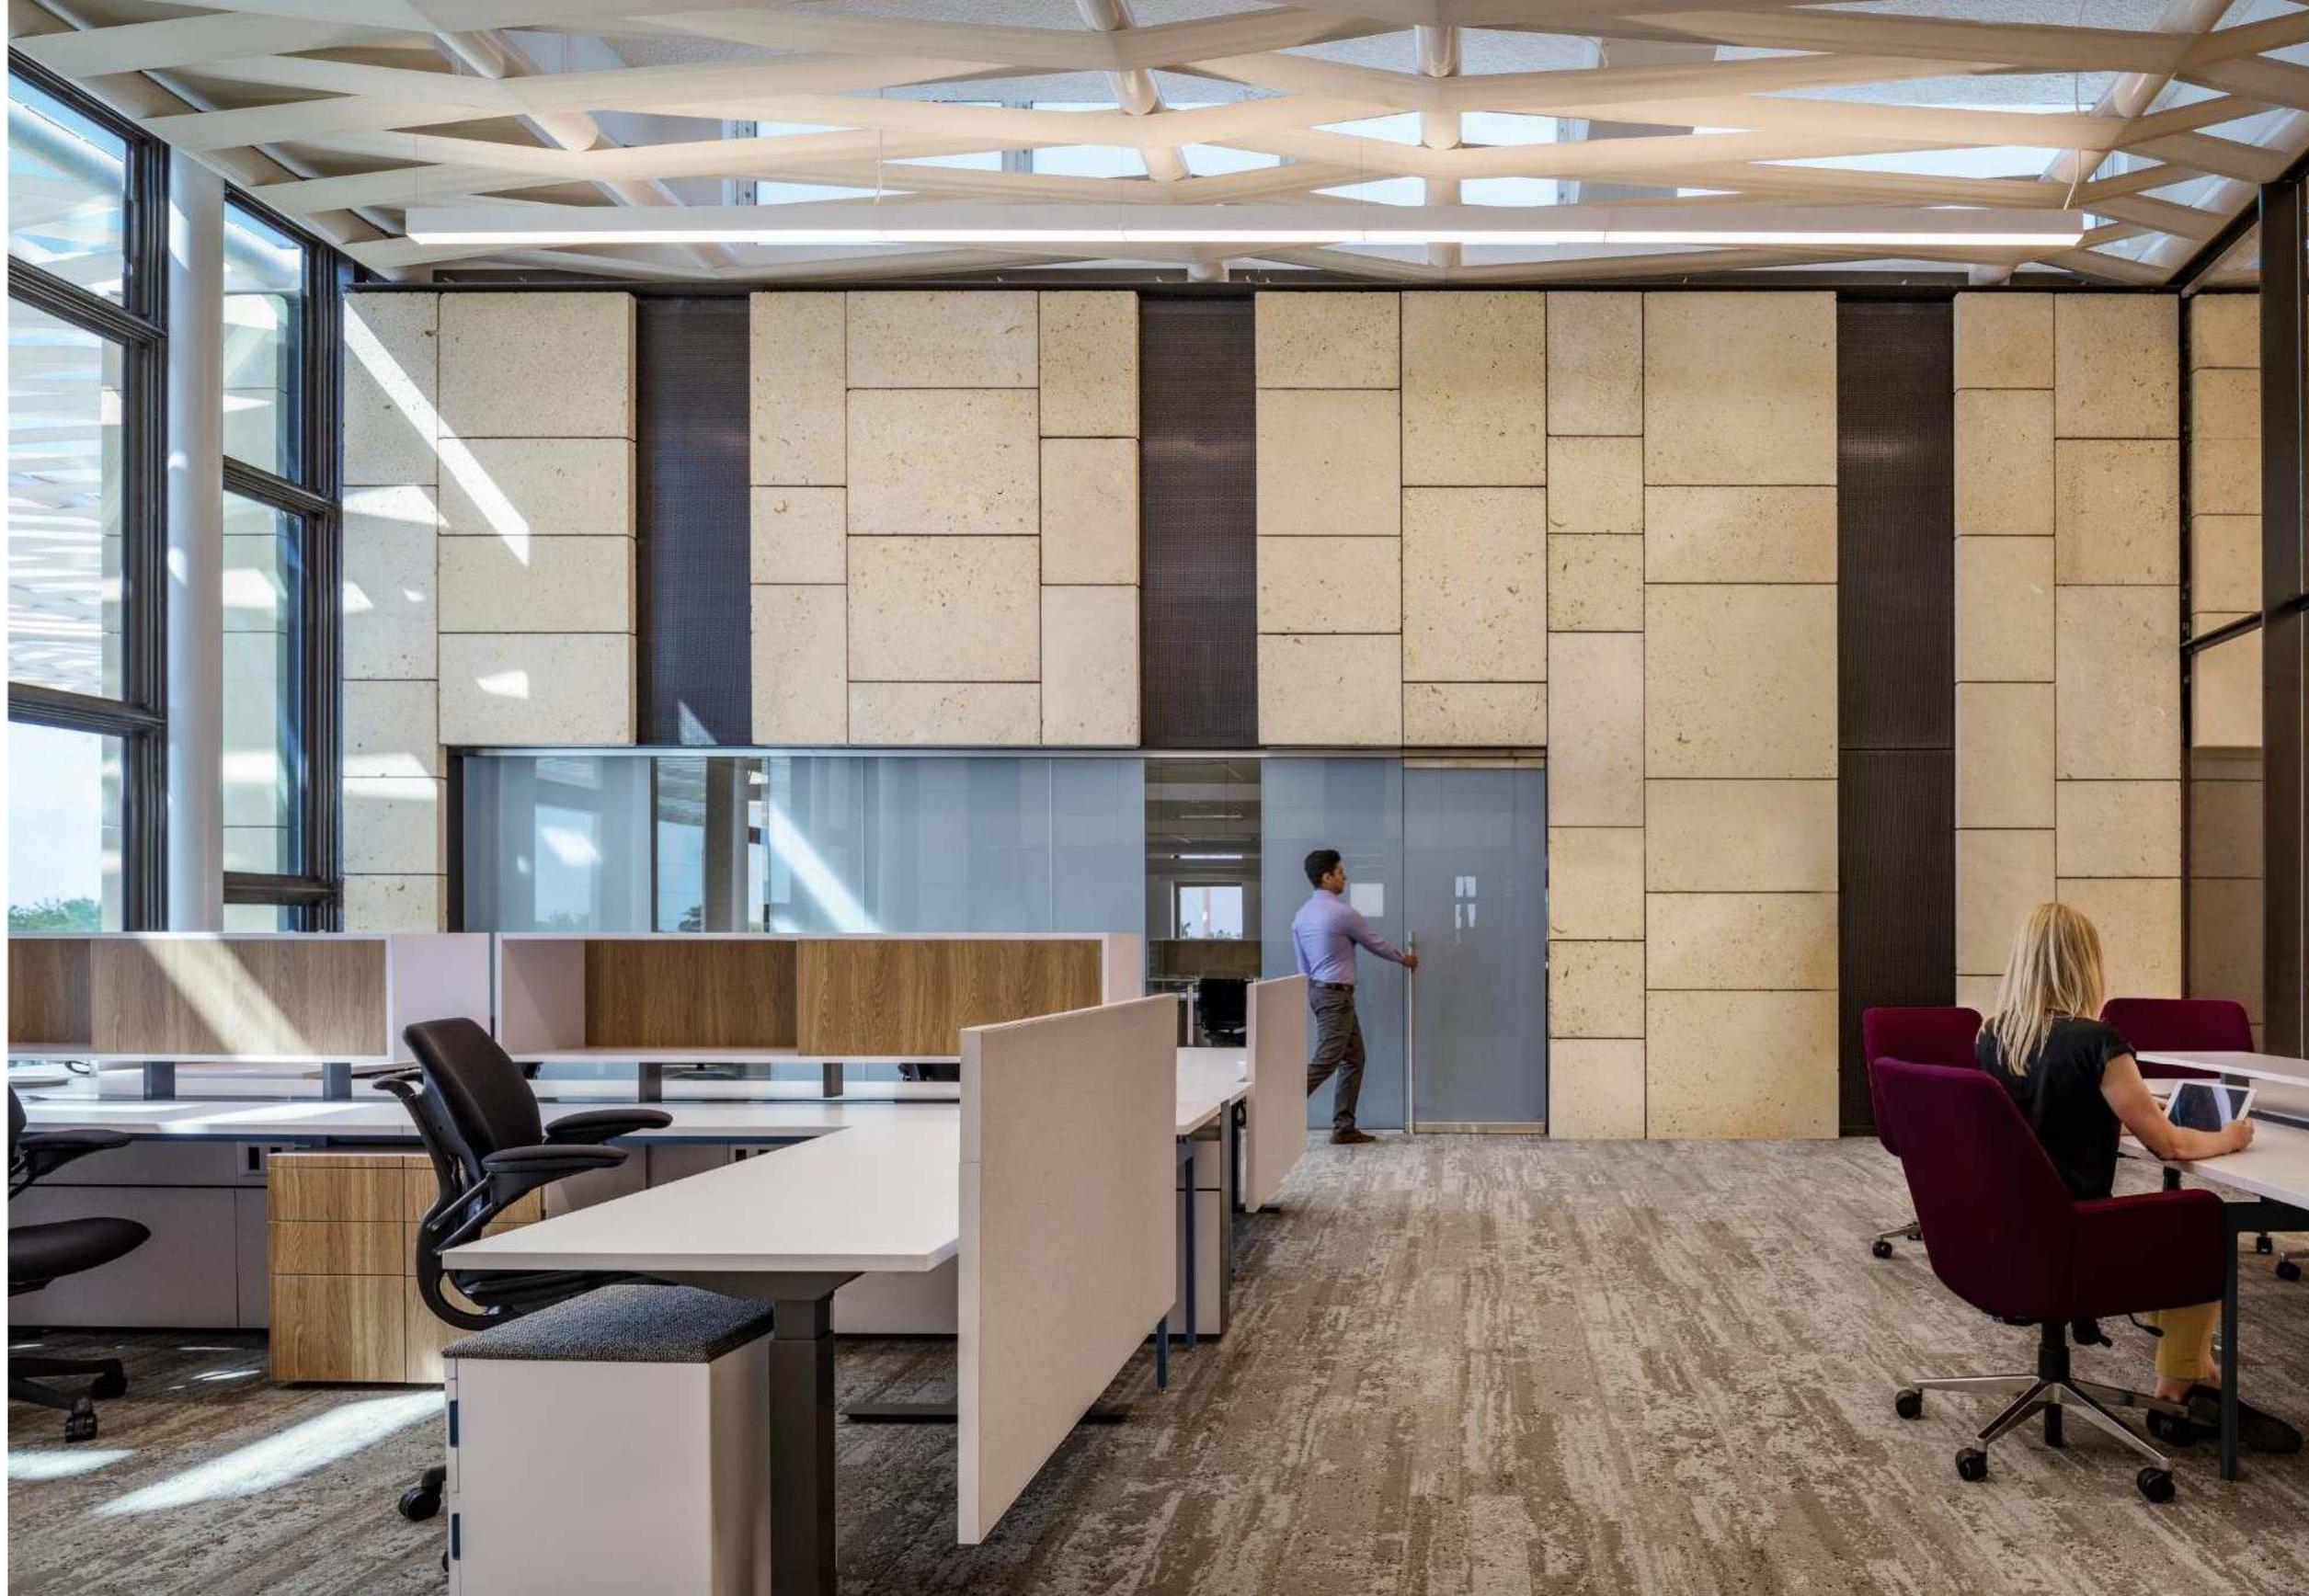
## SUSTAINABILITY

While the climate in Matamoros is typically hot and dry, heavy rains in early fall can cause the Rio Grande to rise and flood the city's streets. To address this issue, the landscape and water catchment system were designed to absorb or capture 90 percent of rainwater runoff. In drier seasons, wastewater from the buildings is treated and used to supply all of the irrigation needs. The project achieved LEED Gold certification.

The site is planted with a range of native plants, shrubs, and trees that provide food and habitat for monarch and other migratory species that arrive spectacularly each winter.

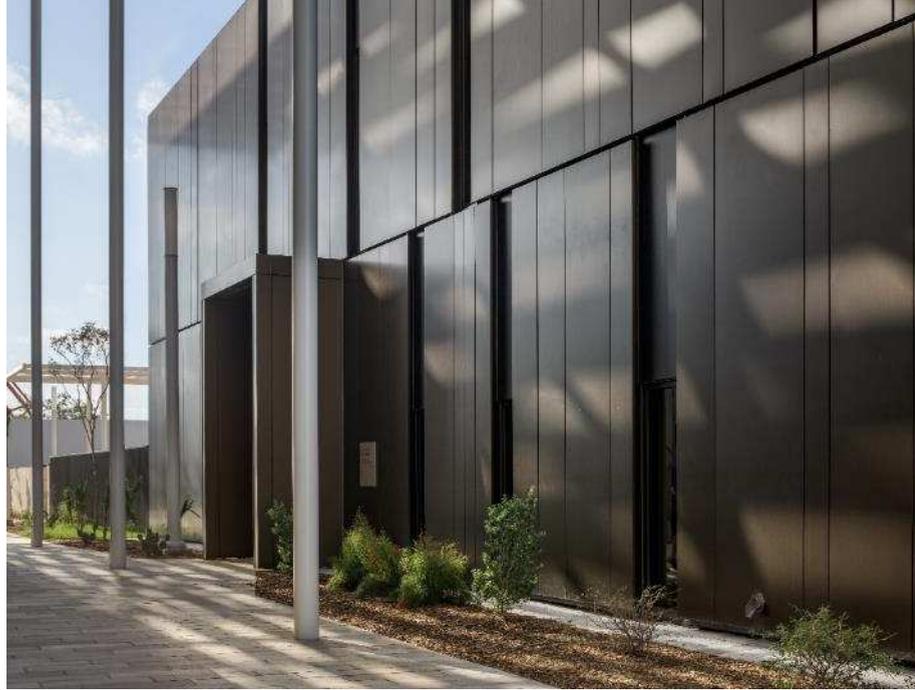
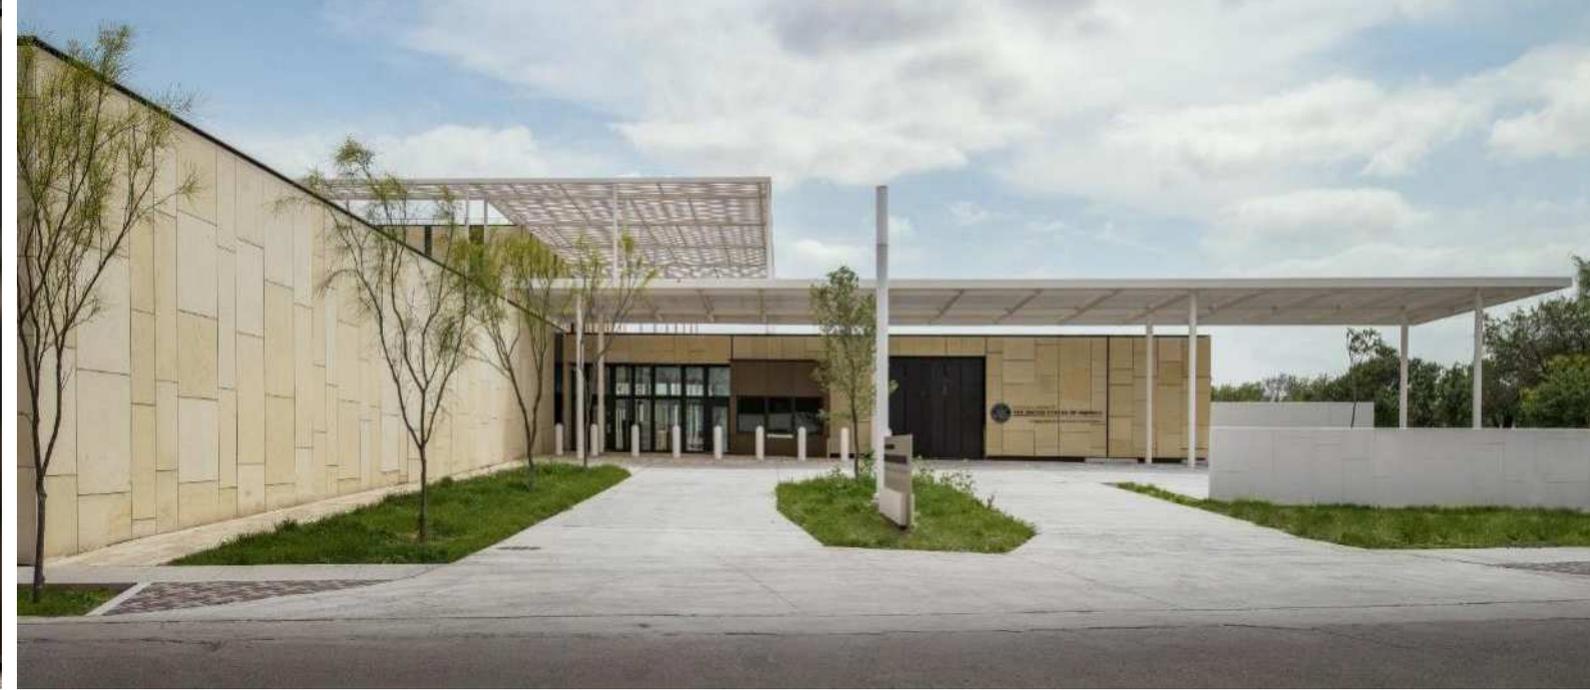
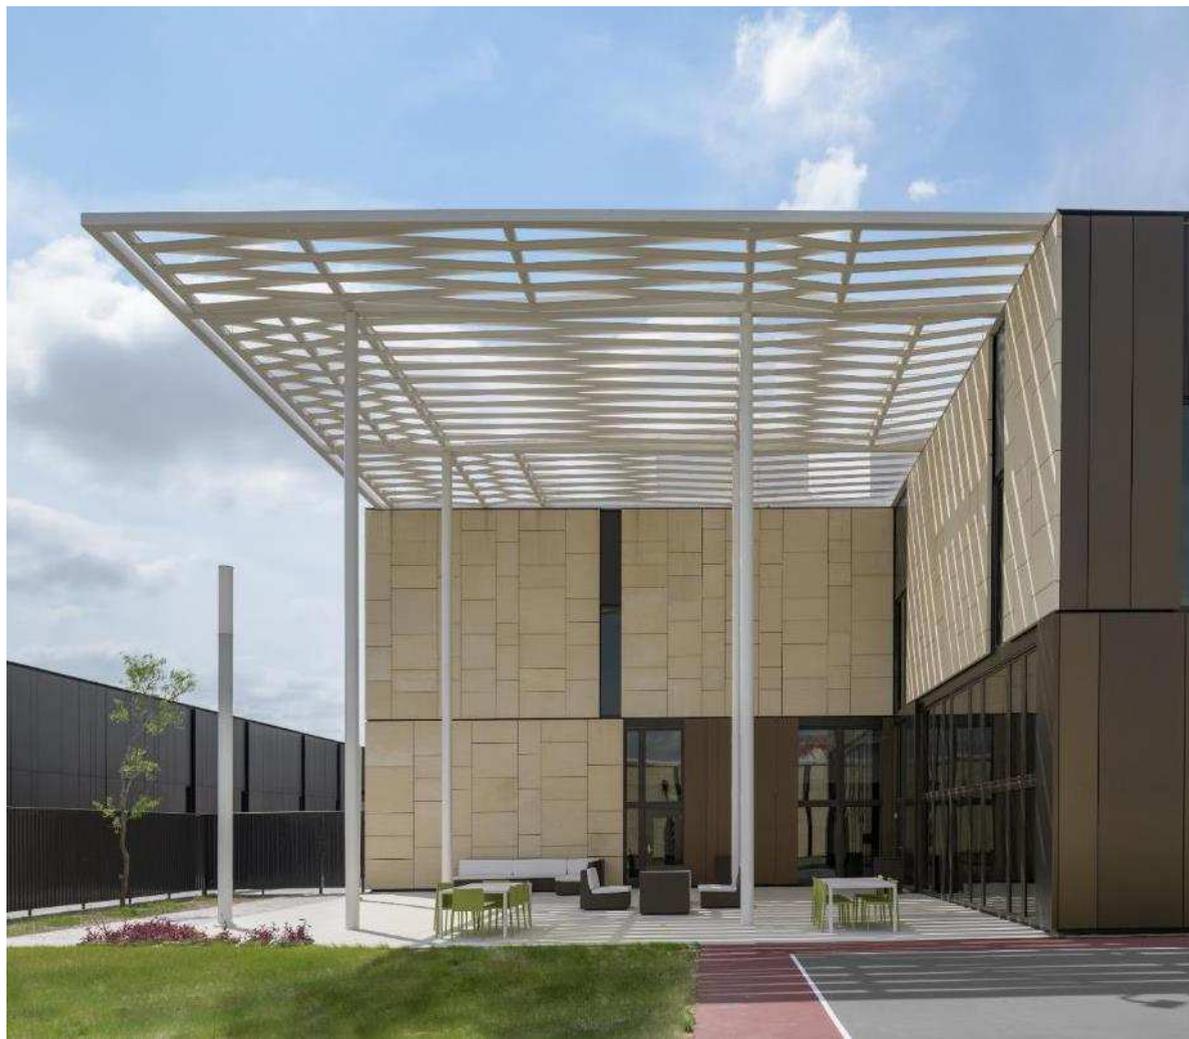
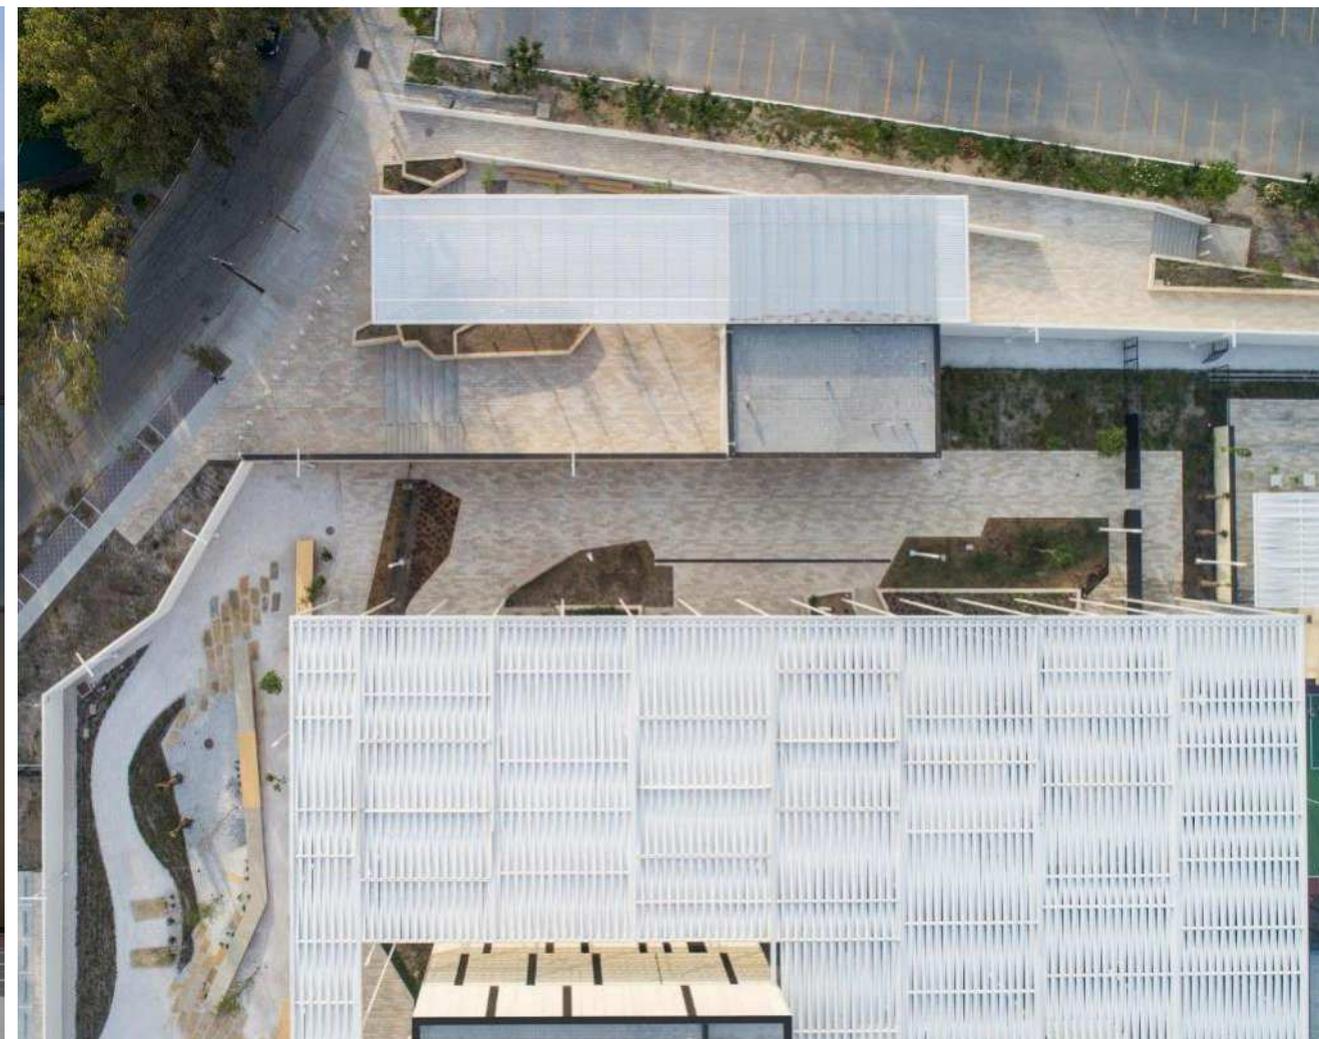
## A LINKED CAMPUS

The design language permeates the entrance pavilions and other buildings on the campus. The residential structure is a simple volume focused on a shaded exterior terrace (bottom left). The residence (top left) is sheathed in light bronze anodized panels with accents of coral stone, reversing the palette of the consulate office building.

The scale, form and palate of the main entry pavilion (top right) is reminiscent of the consular pavilion (bottom right).
